TECHNICAL REPORT (DESCRIPTIVE REPORT)

Performance-based routine maintenance, “Fierzë-B.Curri, B.Curri - Cërrnicë, D/Sopot-Kam”
48.2 km

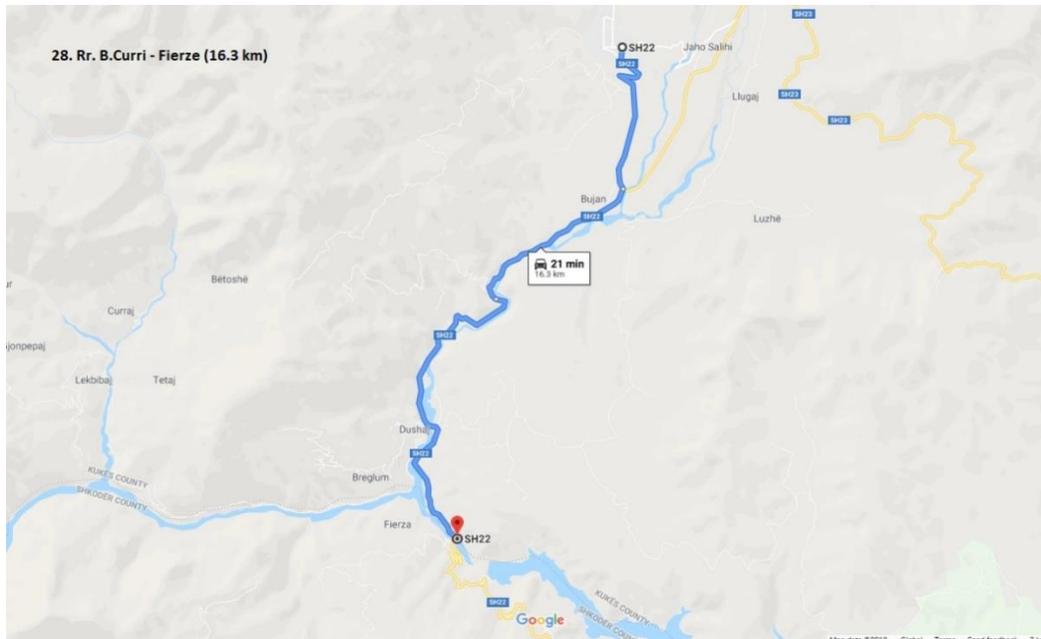
Fierzë-B.Curri 16.3 km

It is a paved segment with one carriageway (width 6 ml).

The asphalt layers' conditions are averagely good.

The side ditches and culverts need partial cleaning.

The road signs and safety need further completion and ongoing maintenance.

The road lies in a highly mountainous terrain and is subject to winter maintenance.

The required level of service is "good".

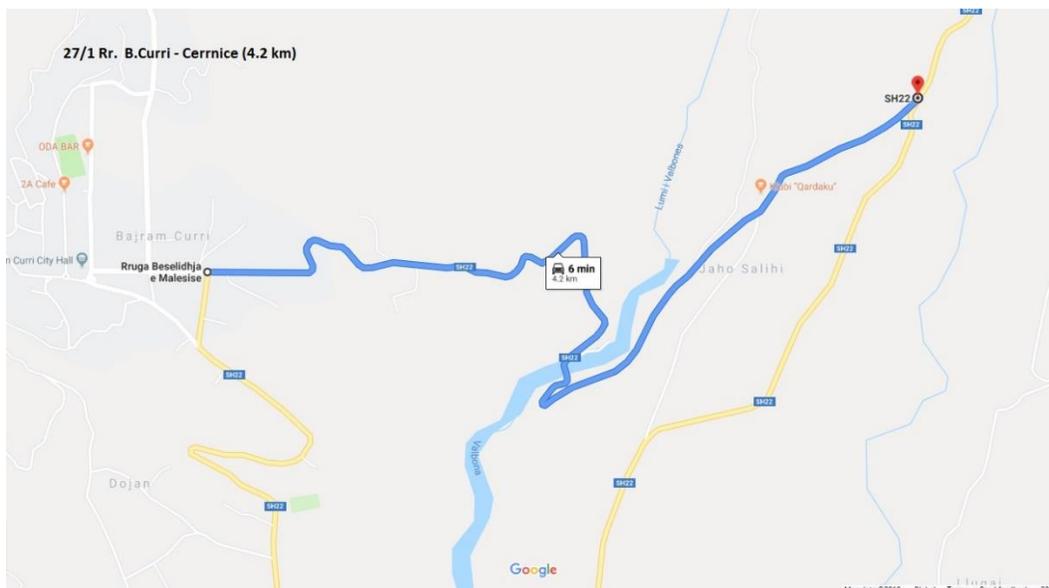
B. Curri - Cërrnicë 4.2 km

It is a paved segment with one carriageway (width 6 ml).

The asphalt layers' conditions are average.

The side ditches and culverts need partial cleaning.

The road signs and safety need further completion and ongoing maintenance.

The road lies in a highly mountainous terrain and is subject to winter maintenance.

The required level of service is "good".

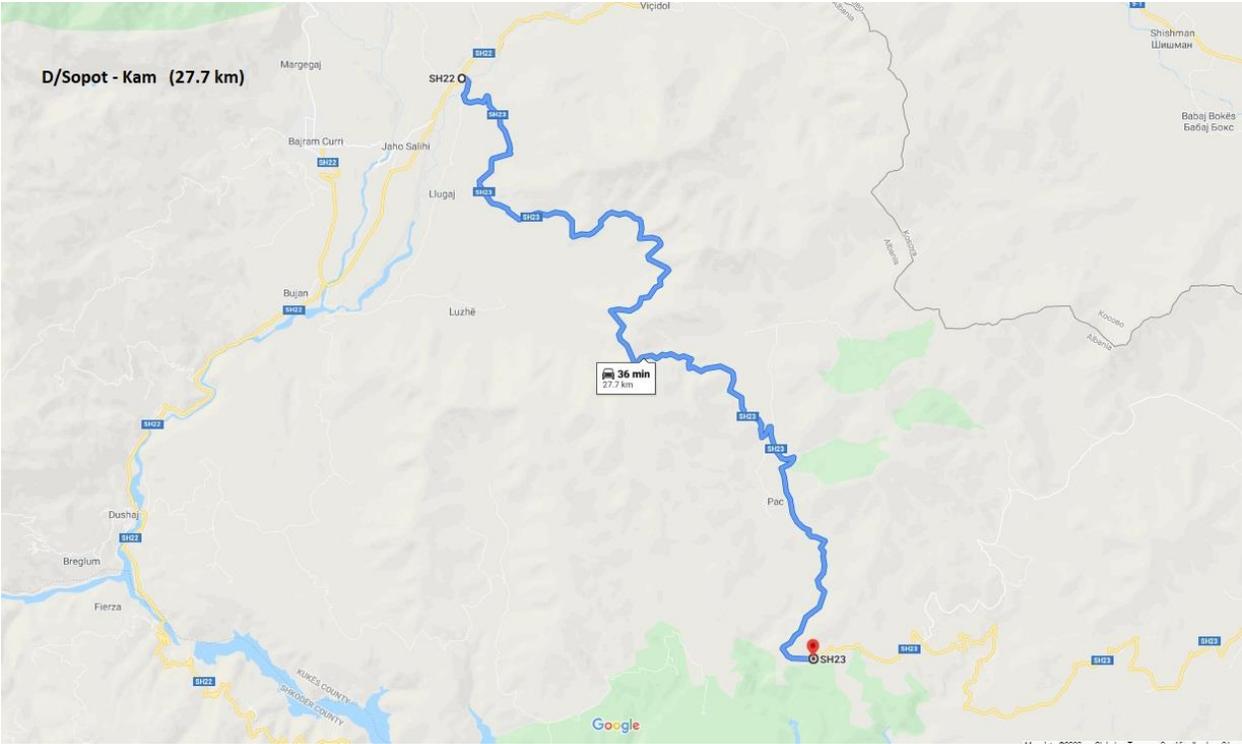
D/Sopot - Kam 27.7 km

It is a paved segment with one carriageway (width 4ml).

The asphalt layers' conditions are averagely good.
The side ditches and culverts need partial cleaning.
The road signs and safety need further completion and ongoing maintenance.
The road lies in a highly mountainous terrain and is subject to winter maintenance.
