TECHNICAL RELATIONSHIP

RE-ASPALATING OF SEGMENTS ROAD

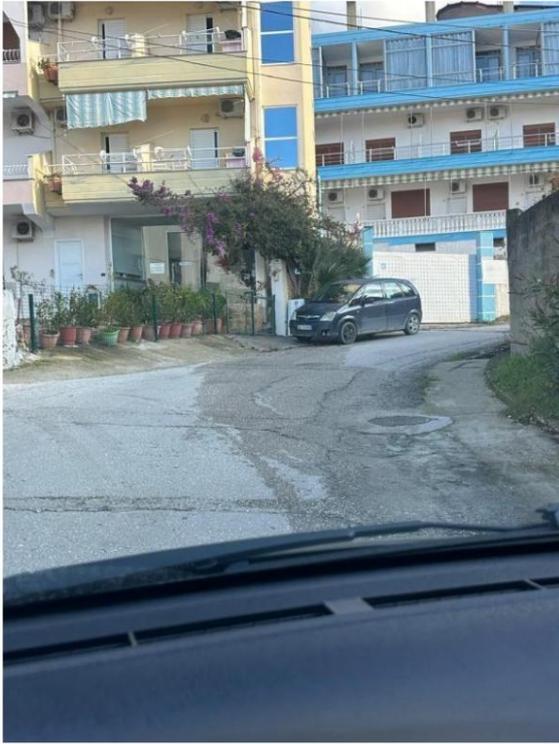
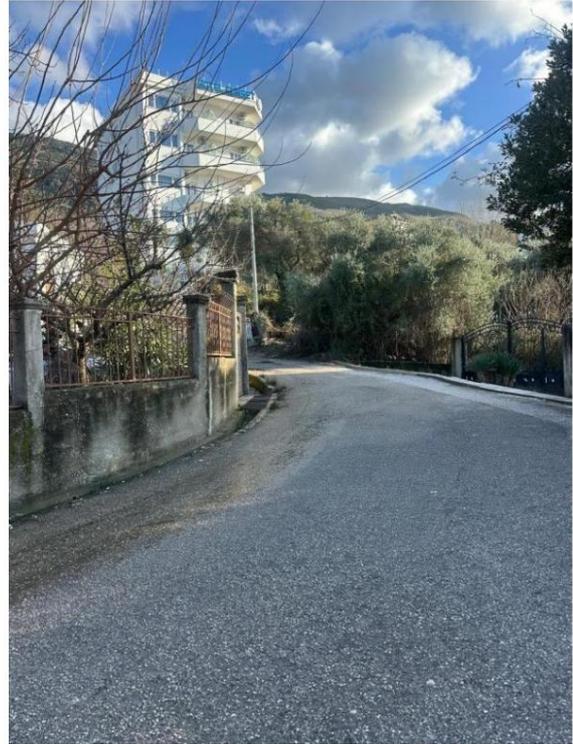
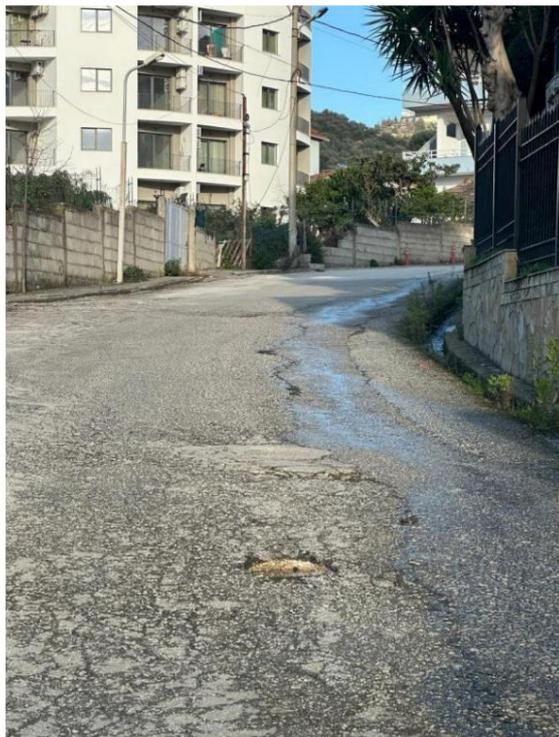
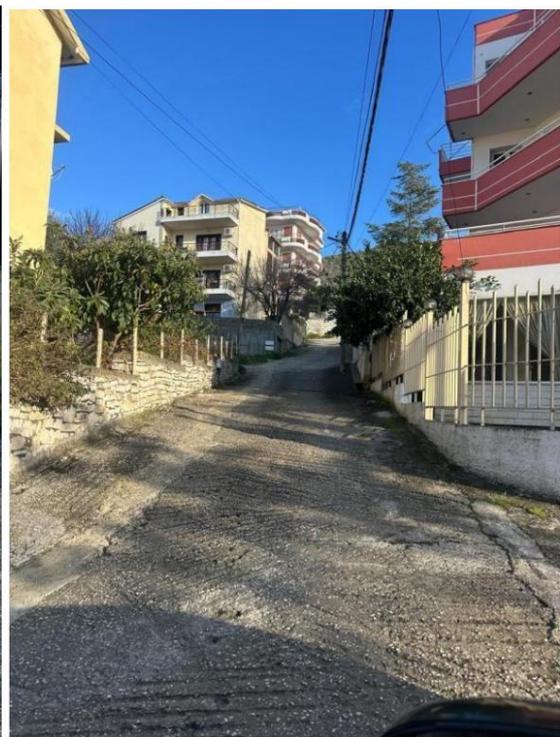
“AZEM SULO” Street,

Photos of the existing condition.

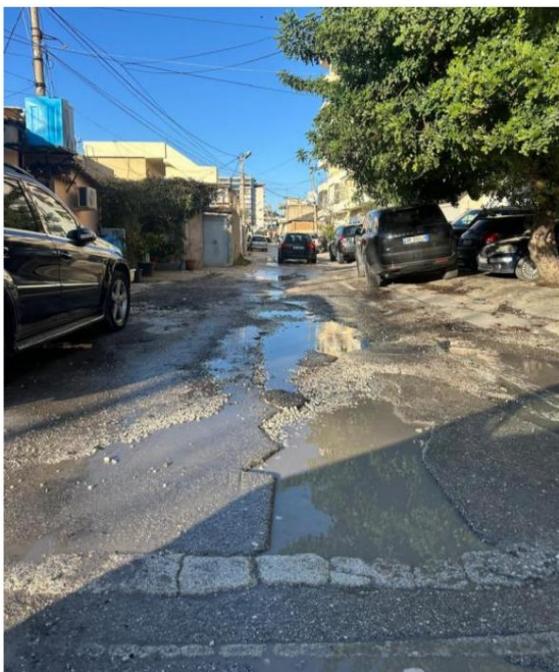
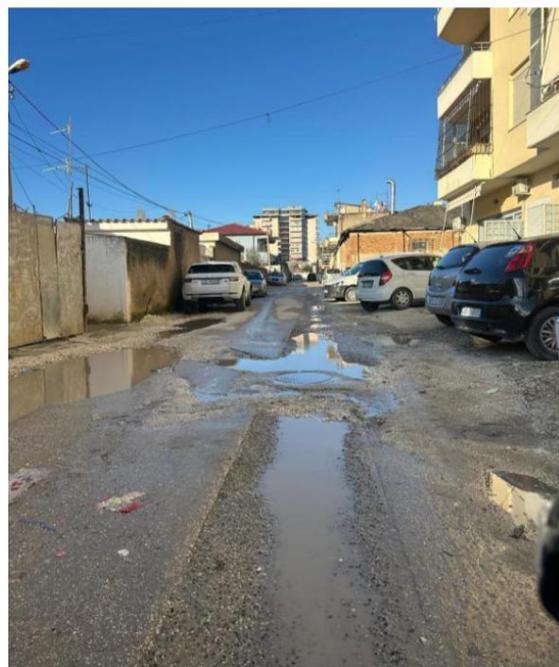
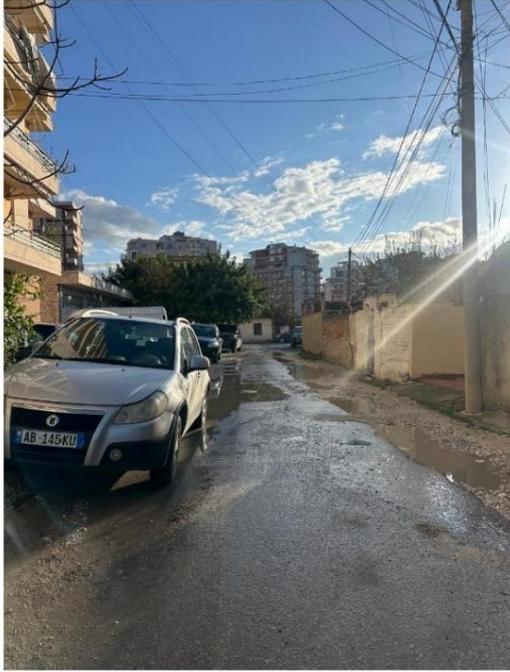
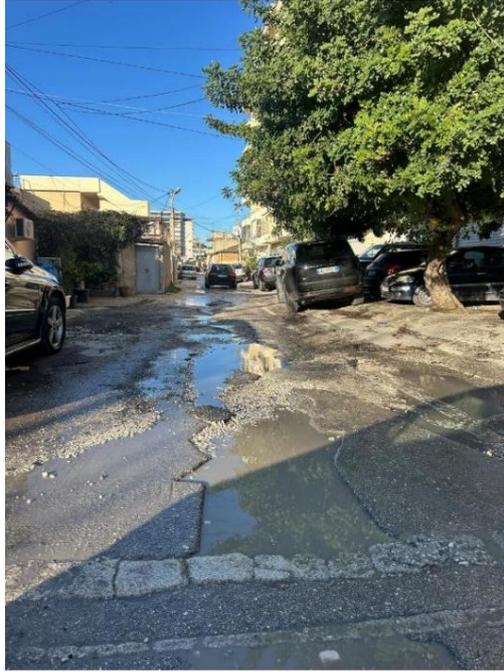
“IBRAHIM SHYTI” Street,

Photos of the existing condition.

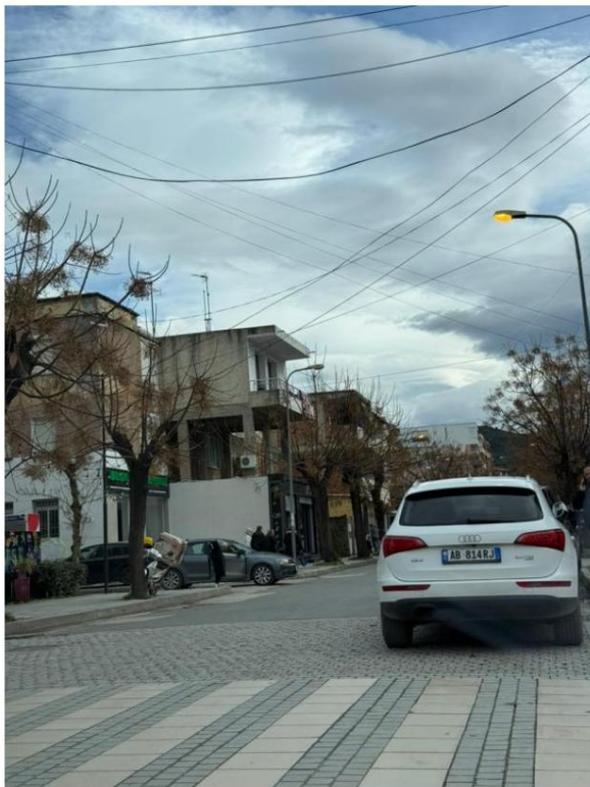
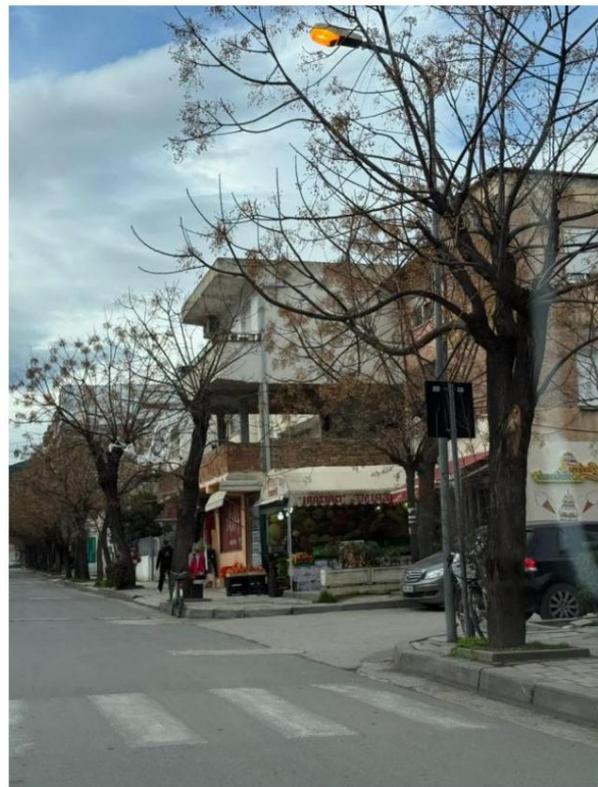
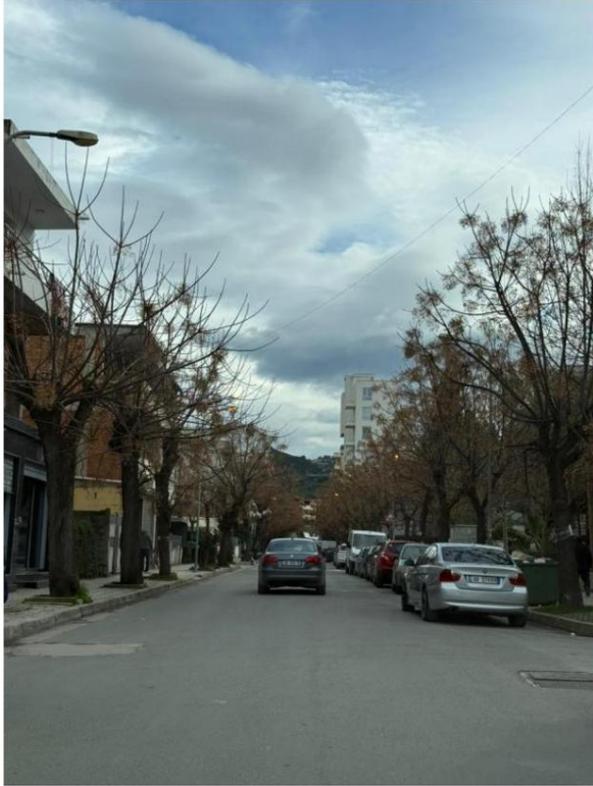
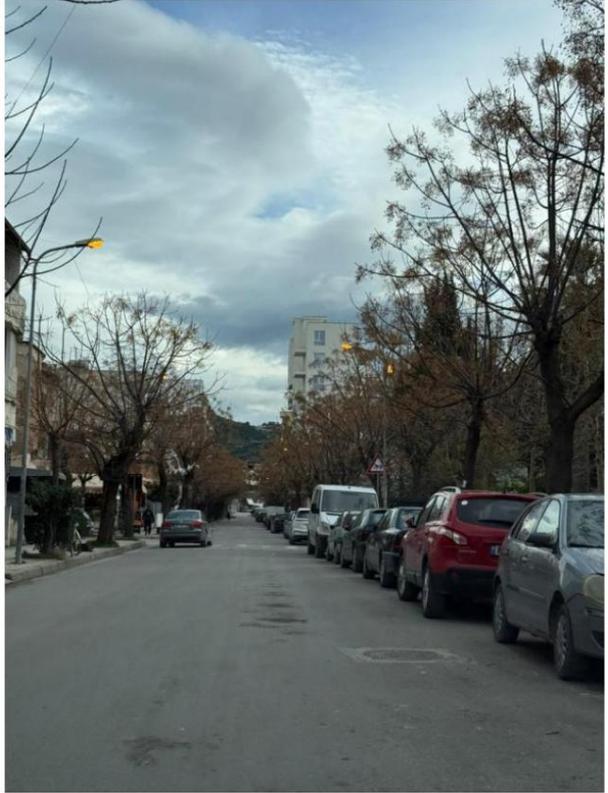
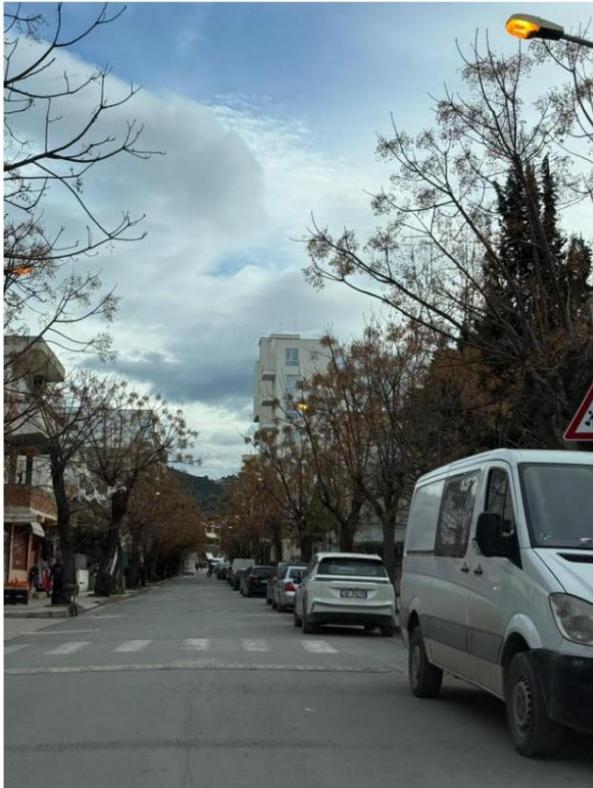
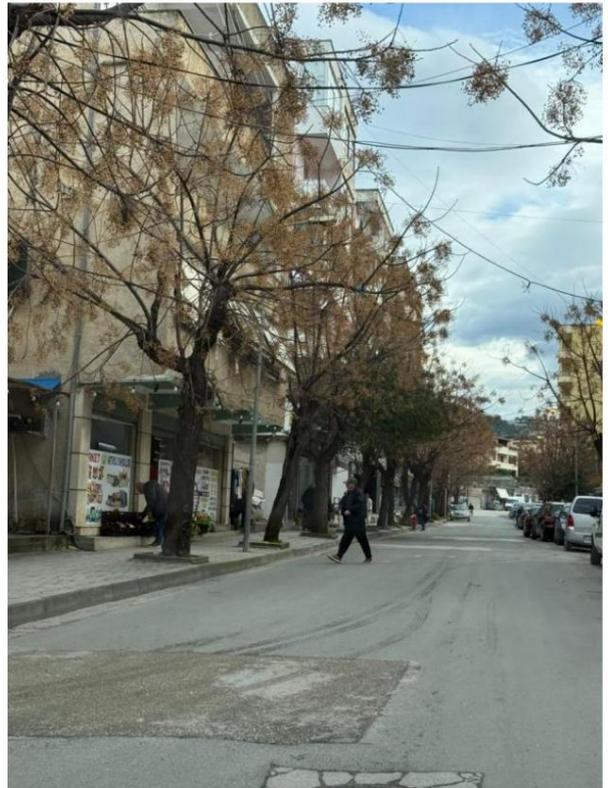
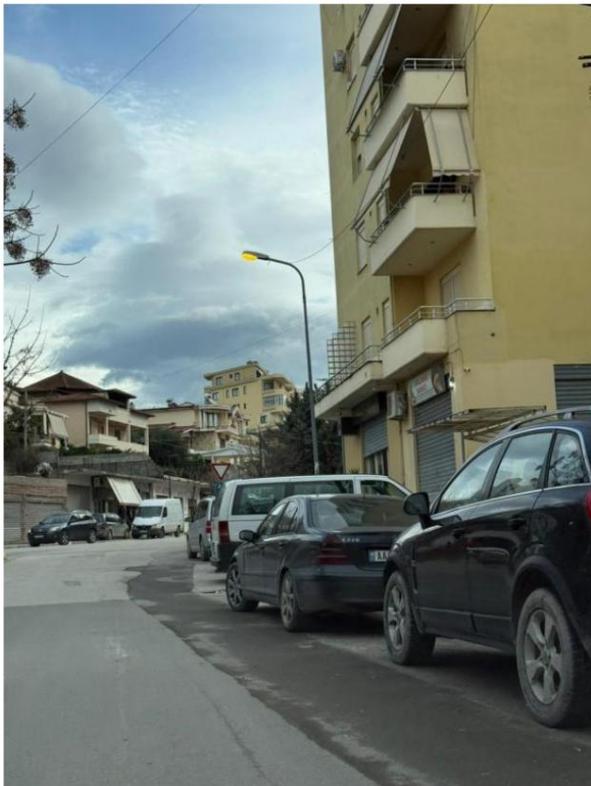
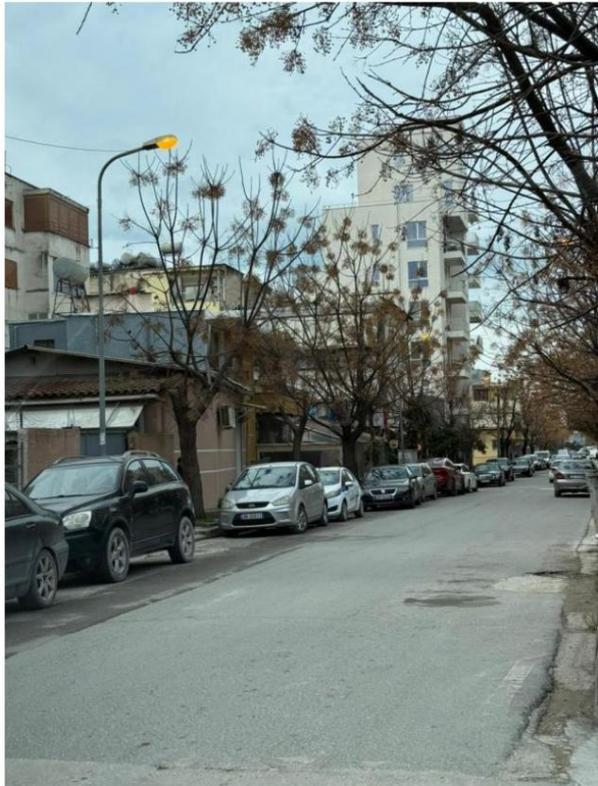
“Mustafa Bello” Street, Region 2

The road is an existing asphalt-paved road, built for years and serving daily vehicle traffic. As a result of the depreciation of the asphalt layer, the impact of atmospheric conditions, interventions carried out for the extension and repair of underground water supply and sewage networks and the lack of periodic maintenance interventions, the road surface presents potholes and local deformations, which make normal vehicle movement difficult and pose a risk to road safety.

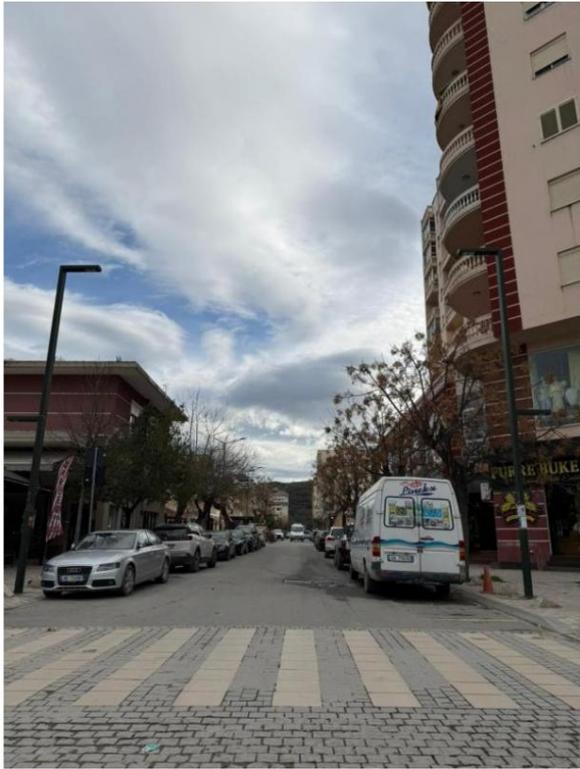
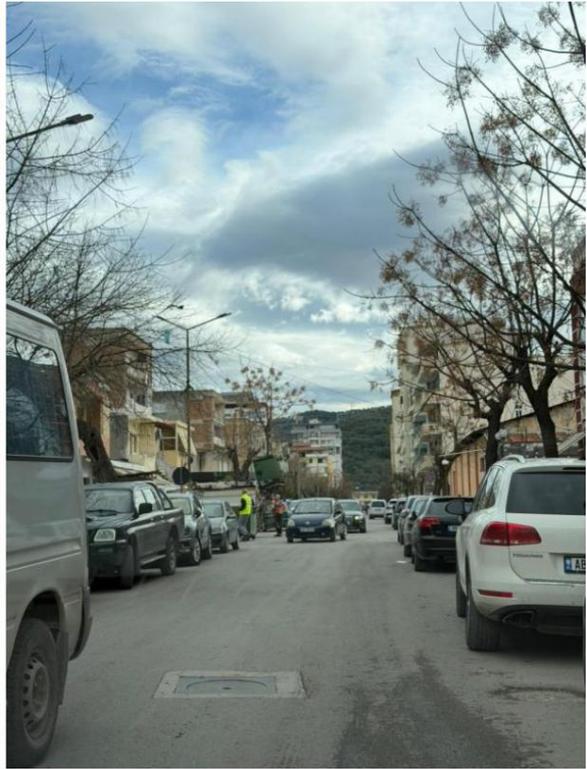
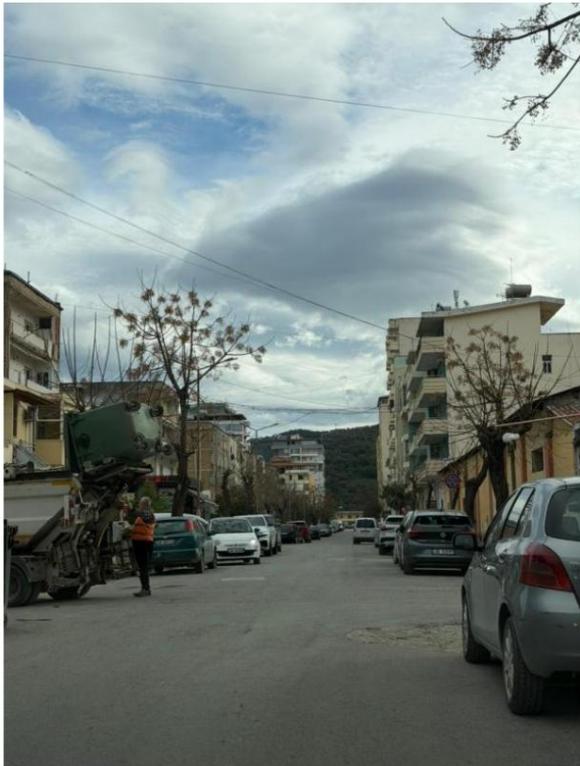
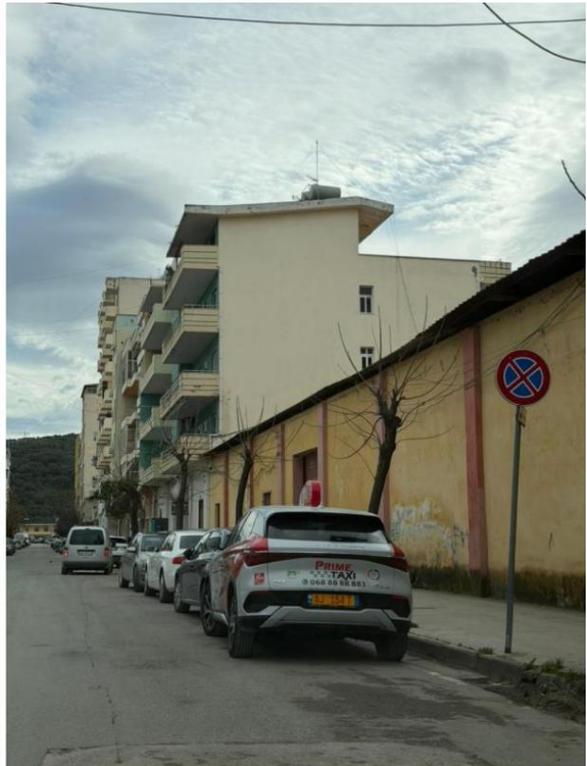
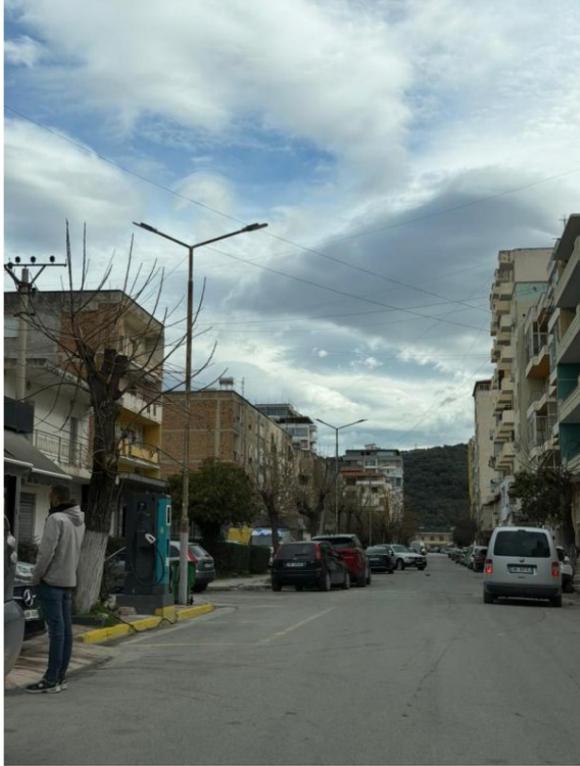
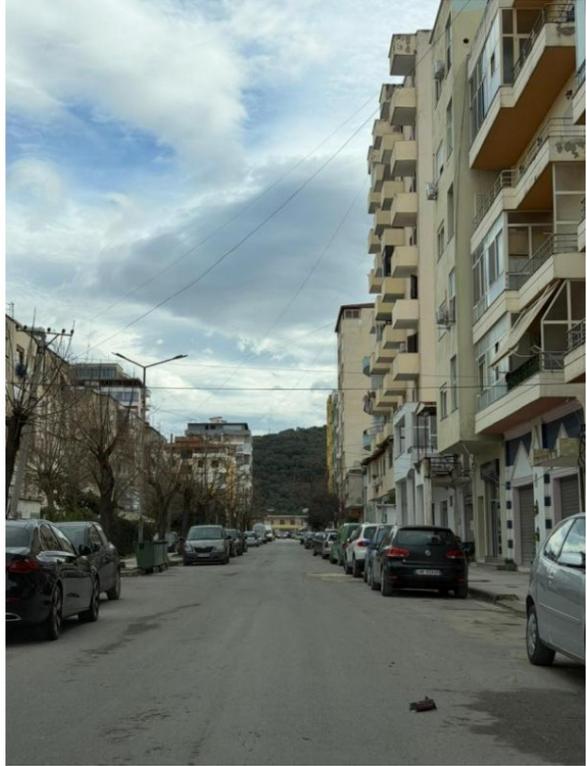
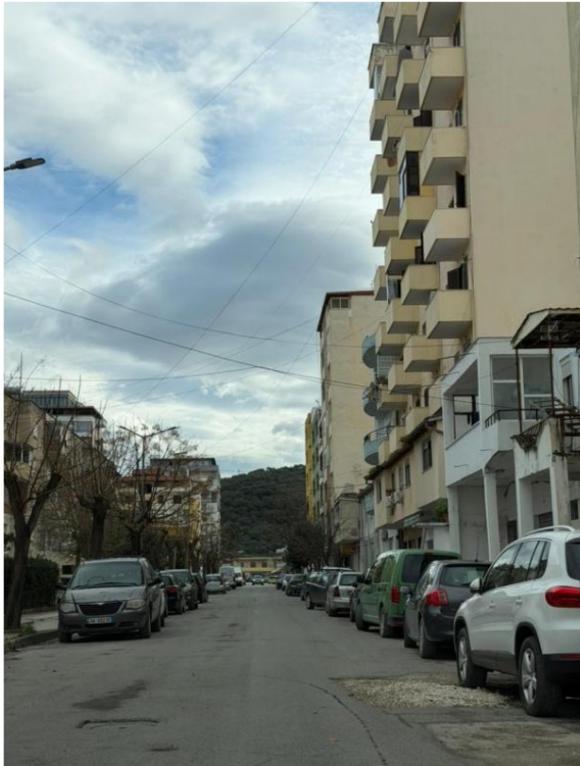
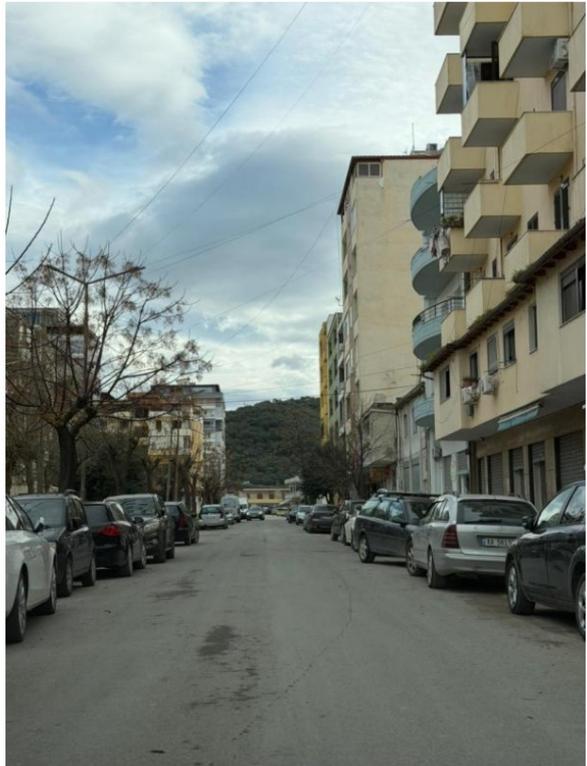
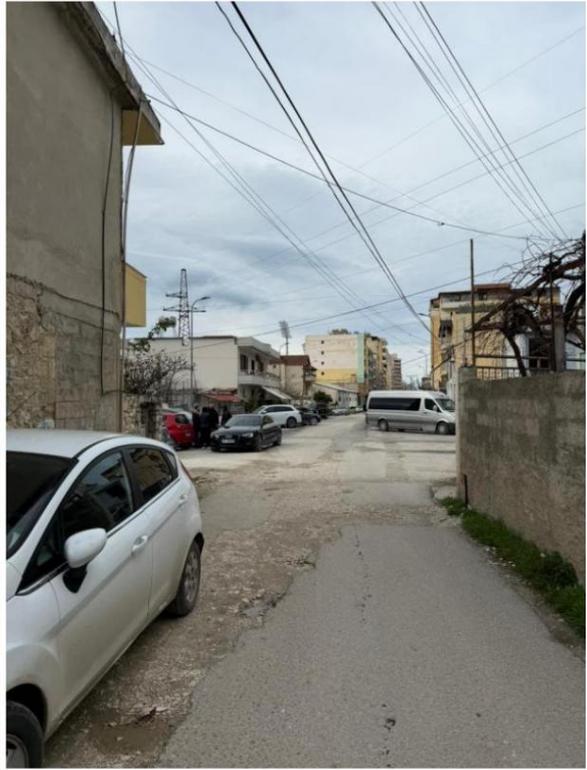
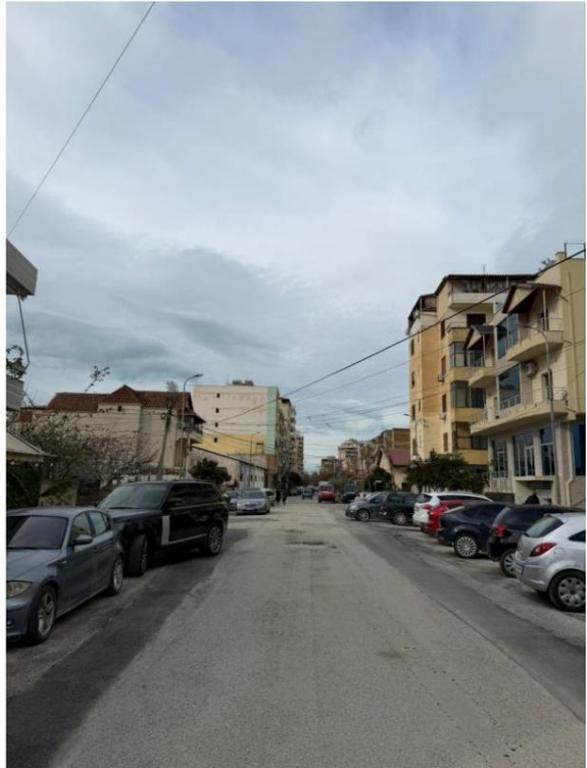
“Dush Strati” Street, Region 2

A two-way local road with worn asphalt, with numerous deformations and repairs on its surface. The road serves as a local axis with a significant flow of vehicles, as well as spontaneously organized parking along both sides of it.

Lack of horizontal signage.

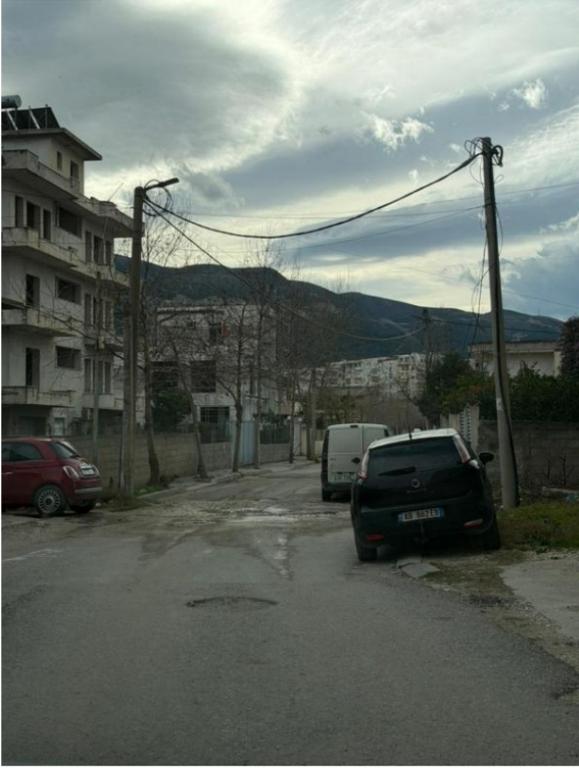
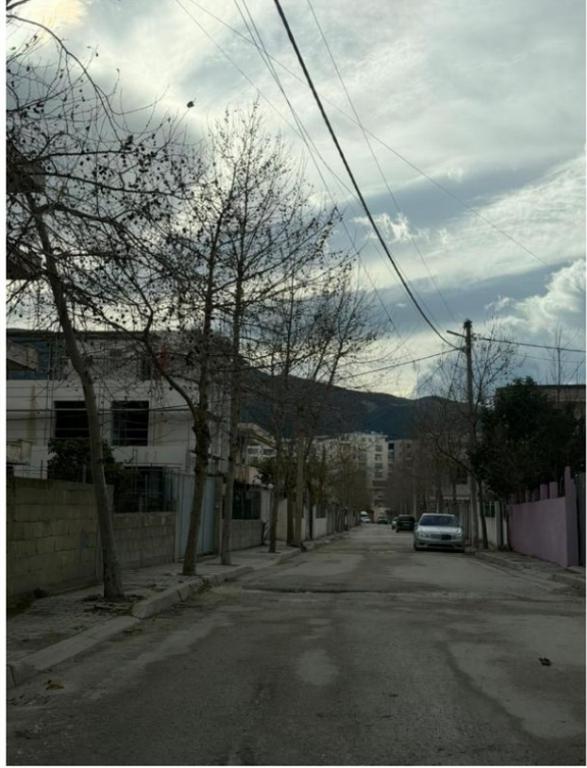
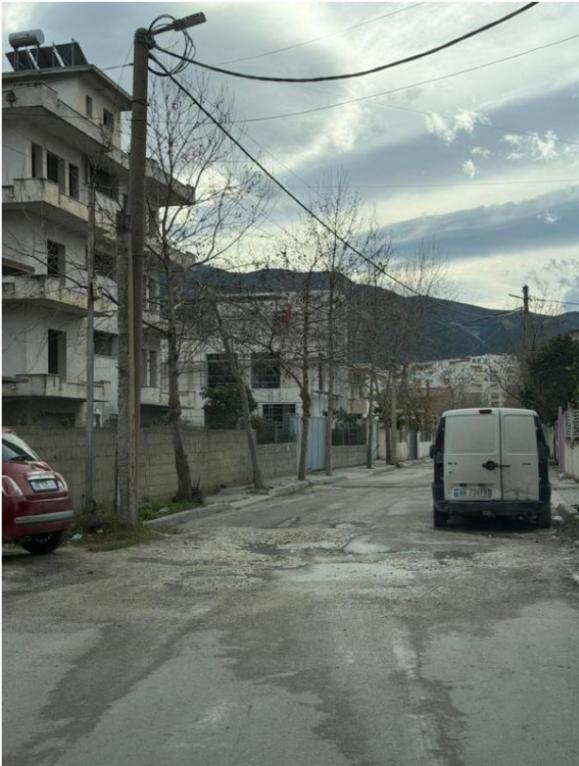
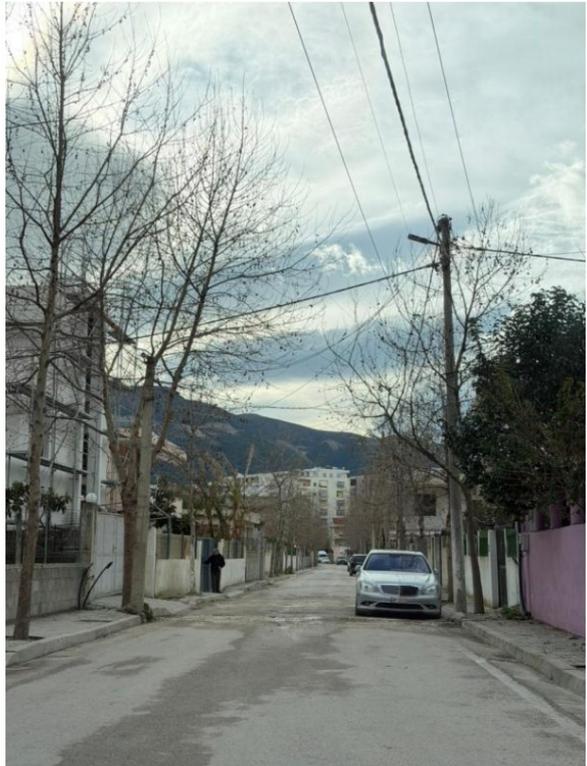
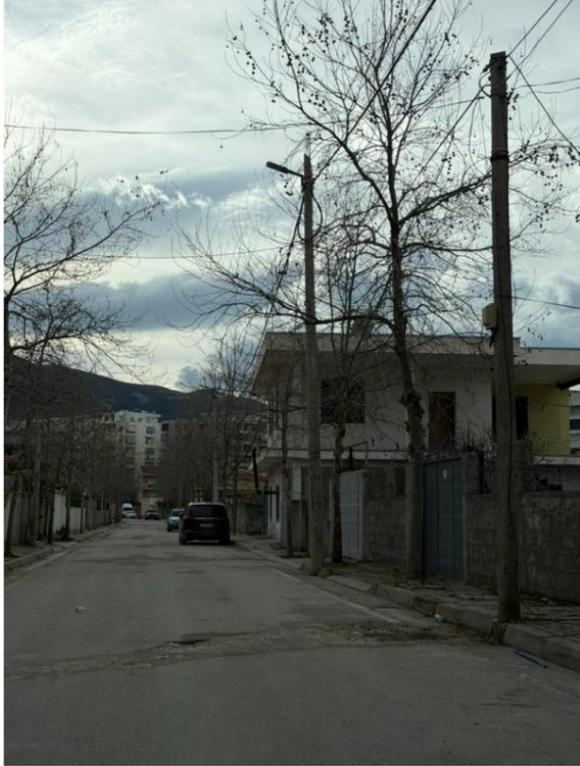
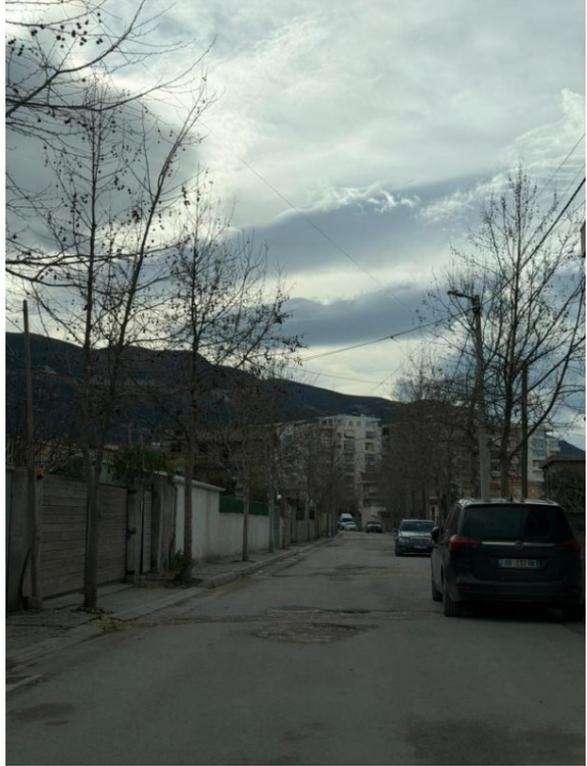
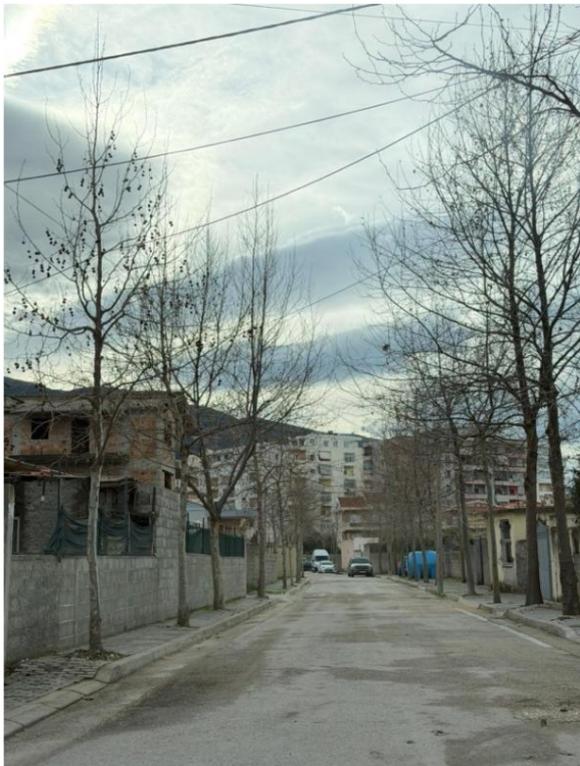
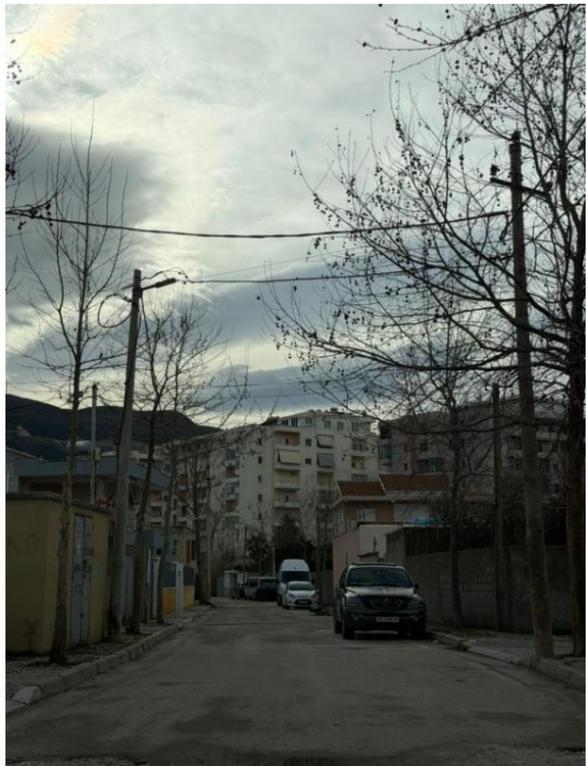
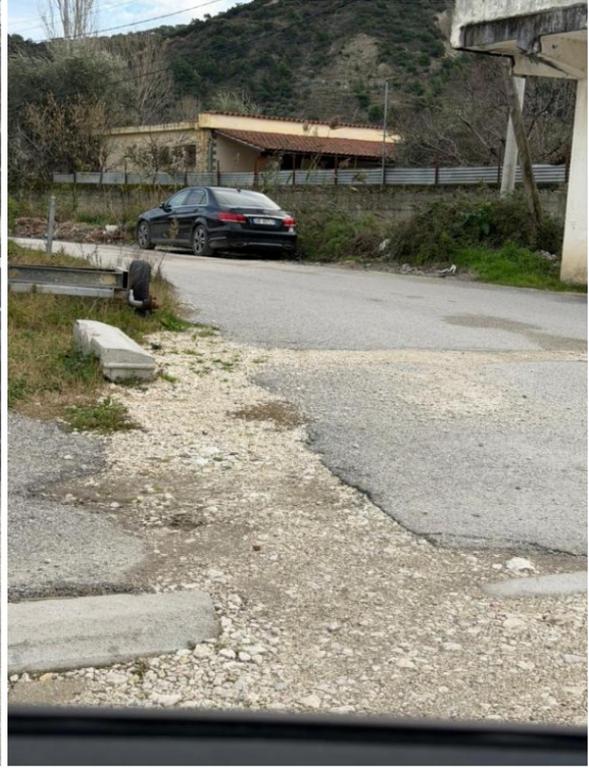
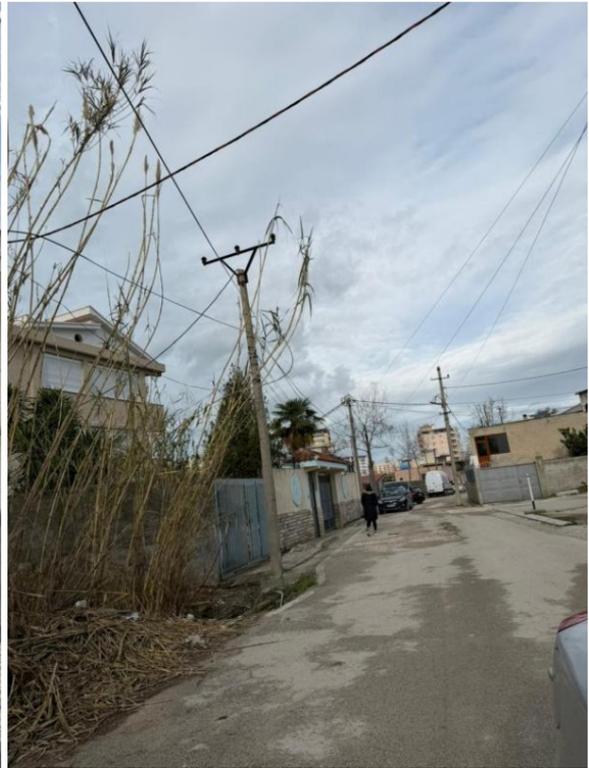
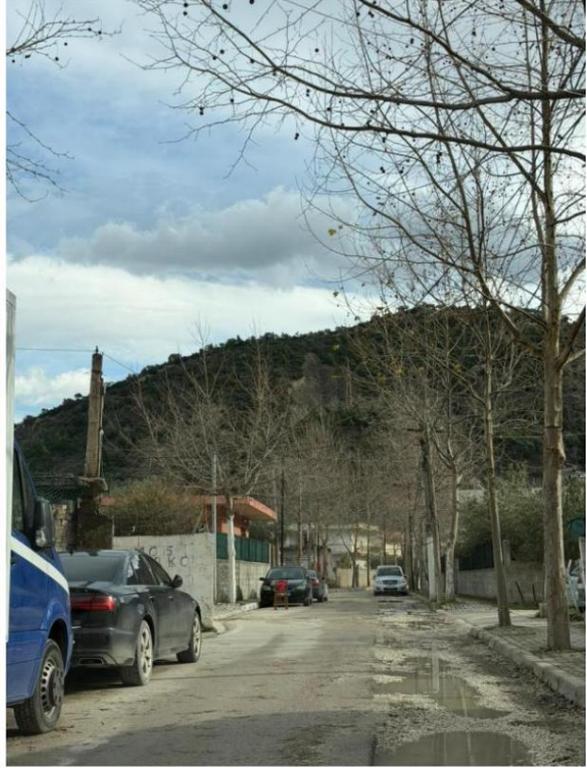
“Kujtim Beqiri” and “Niko Hoxha” Streets, Region 2

A two-way local road with worn asphalt, with numerous deformations and repairs on its surface. The road serves as a local axis with a significant flow of vehicles, as well as spontaneously organized parking along both sides of it.

Lack of horizontal signage.

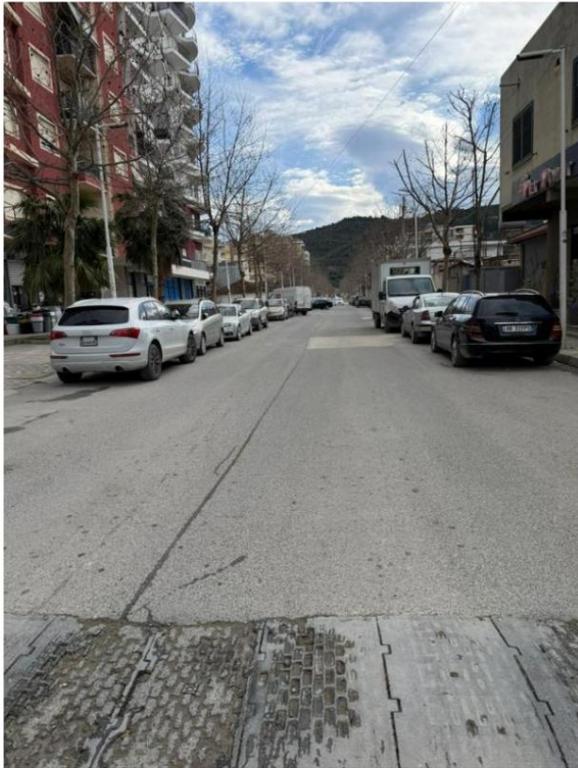
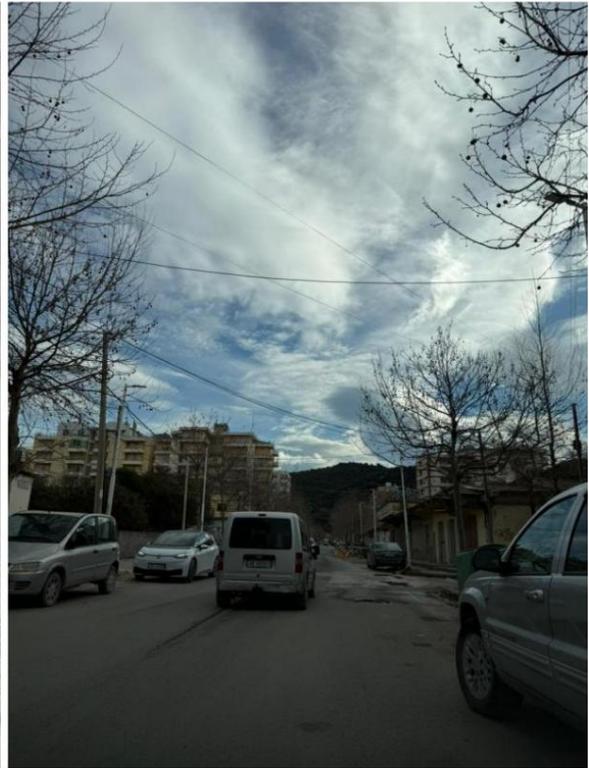
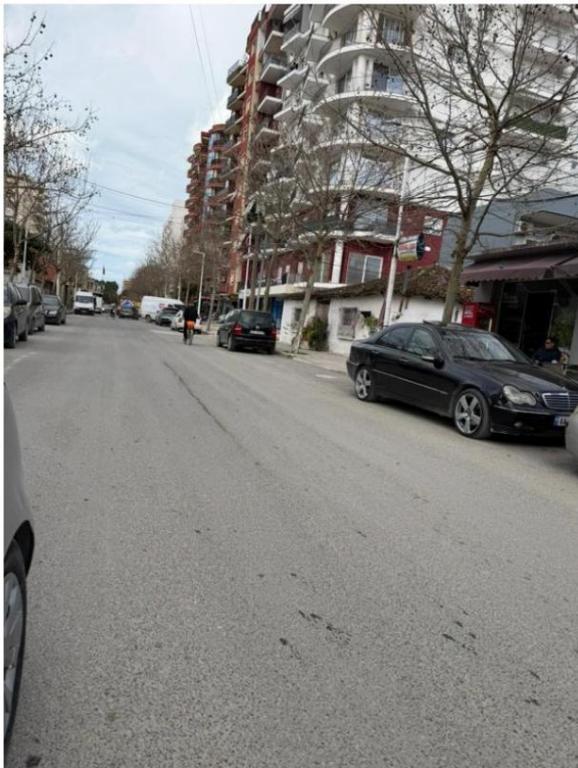
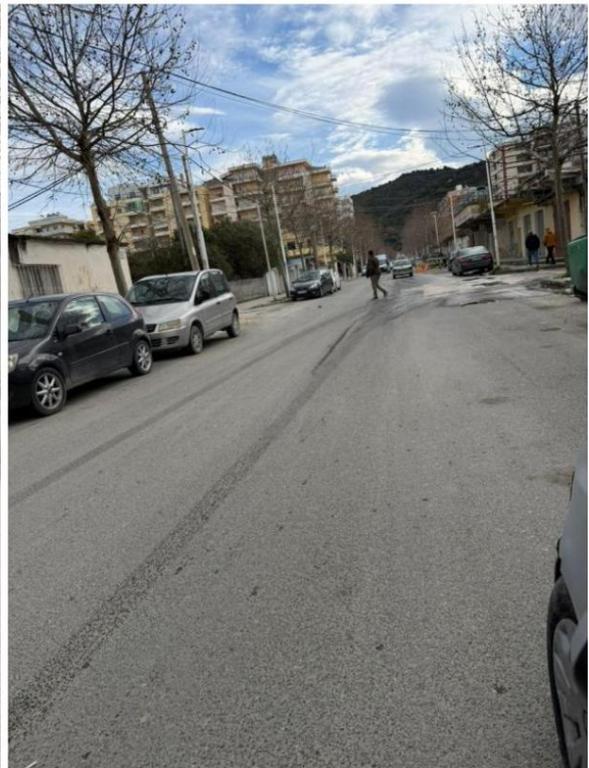
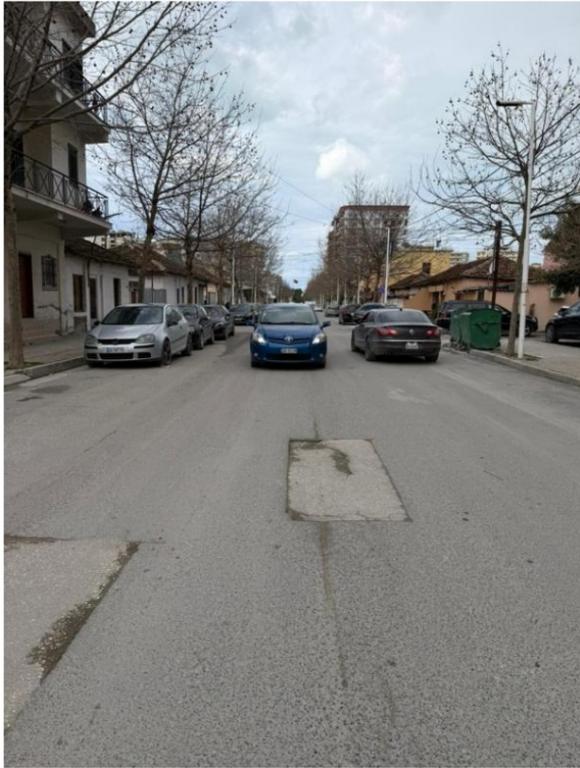
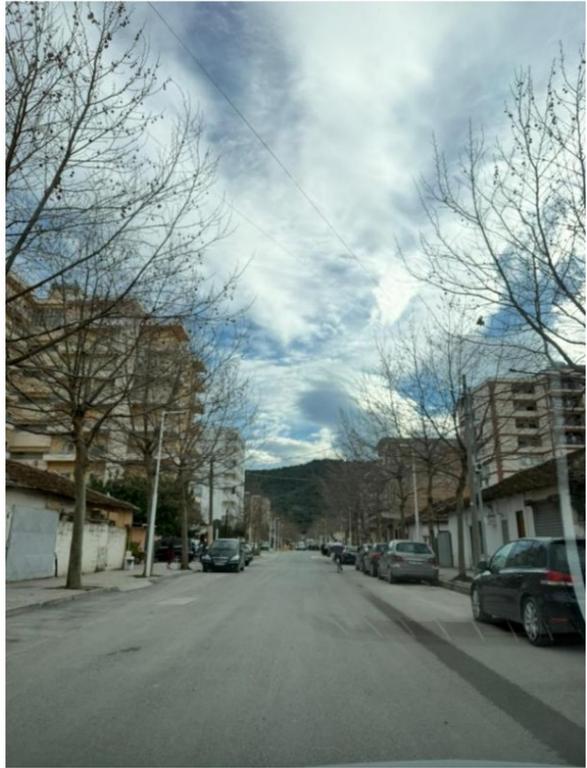
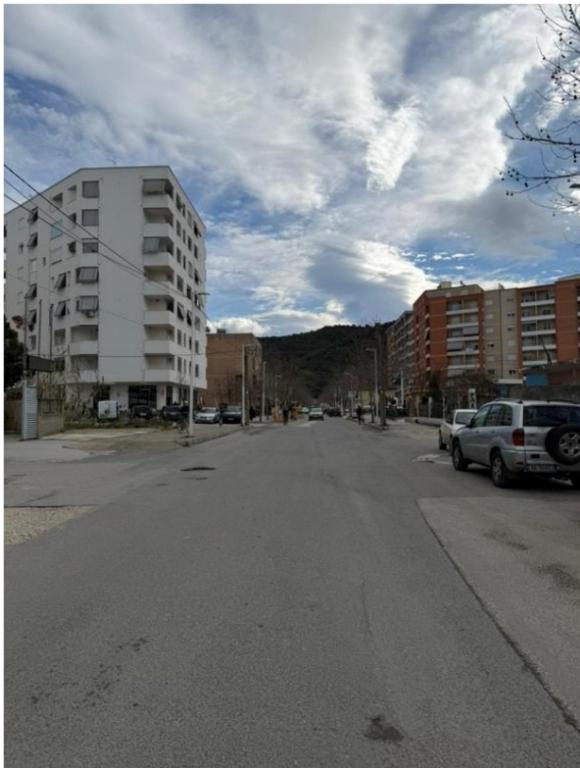
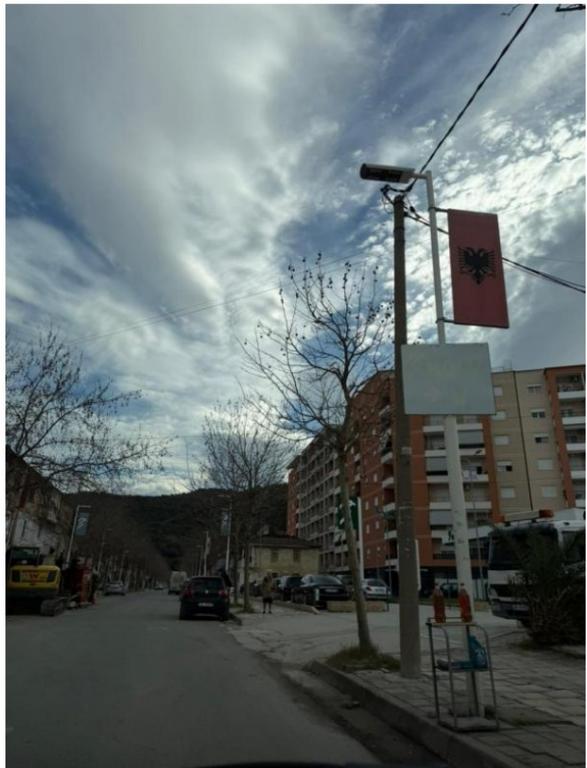
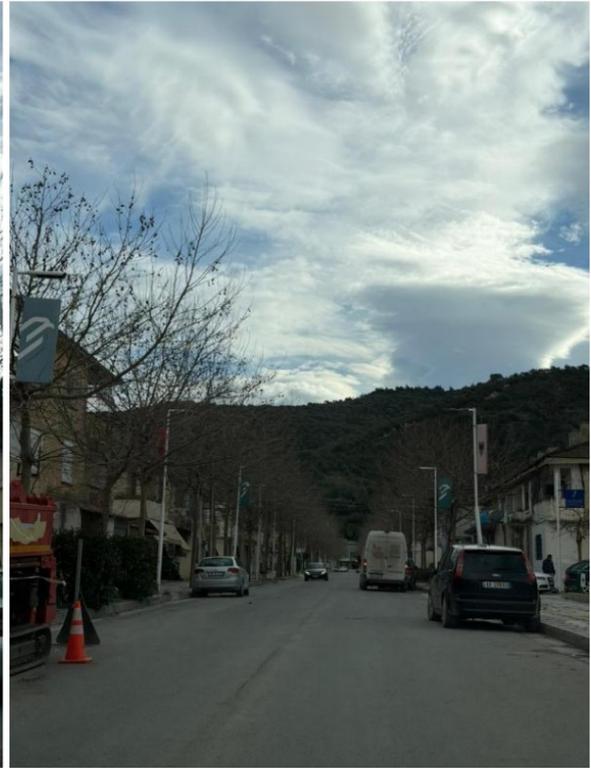
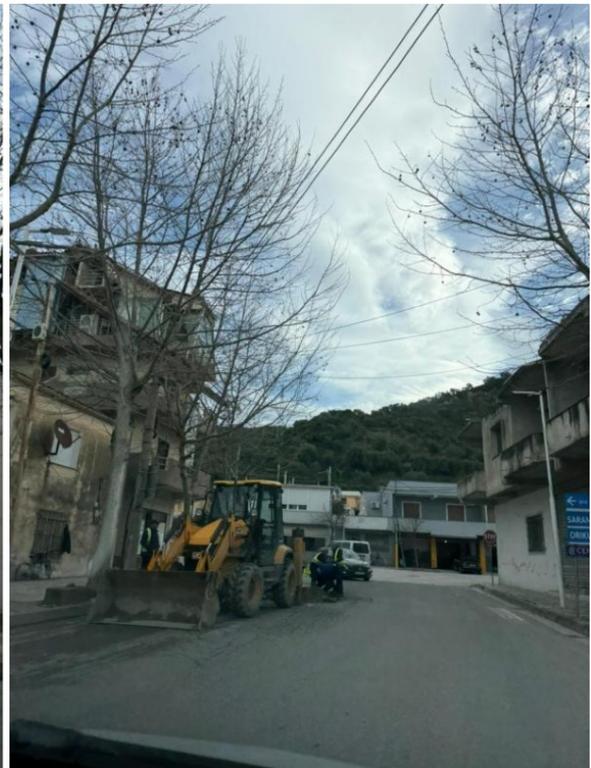
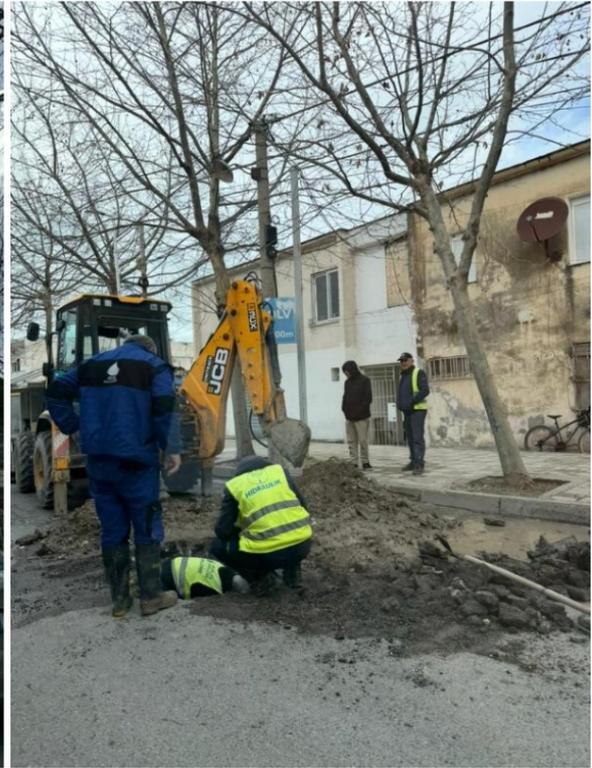
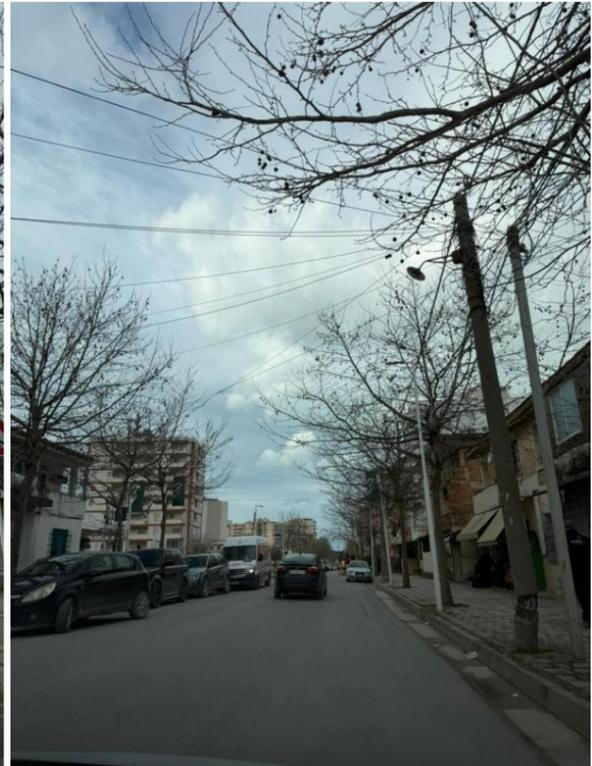
“Pelivan Leskaj” Street, Region 2

A two-way local road with worn asphalt, with numerous deformations and repairs on its surface. The road serves as a local axis with a significant flow of vehicles, as well as spontaneously organized parking along both sides of it.

Lack of horizontal signage.
