TECHNICAL RELATIONSHIP

RE-ASPALATING OF SEGMENTS ROAD

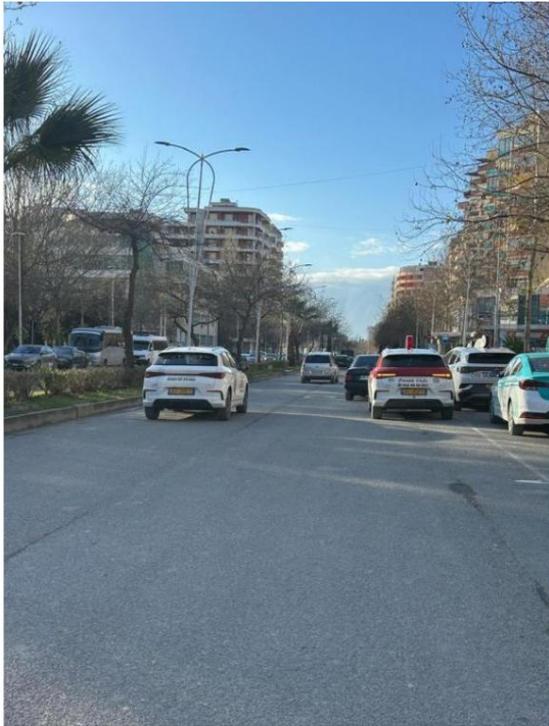
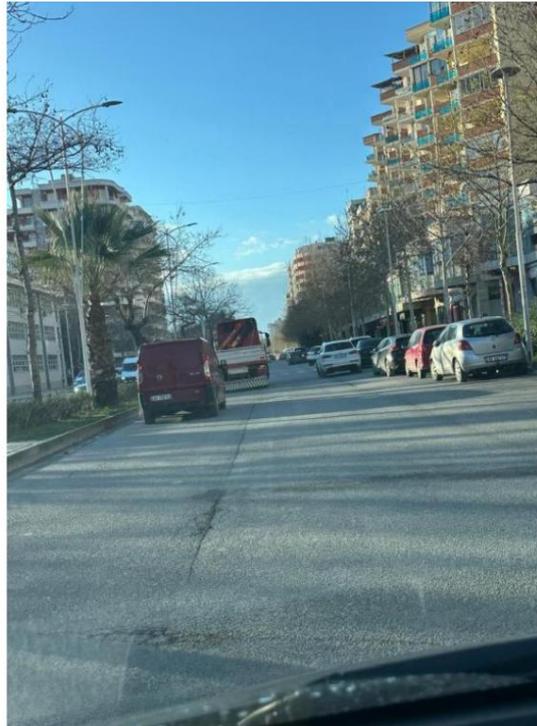
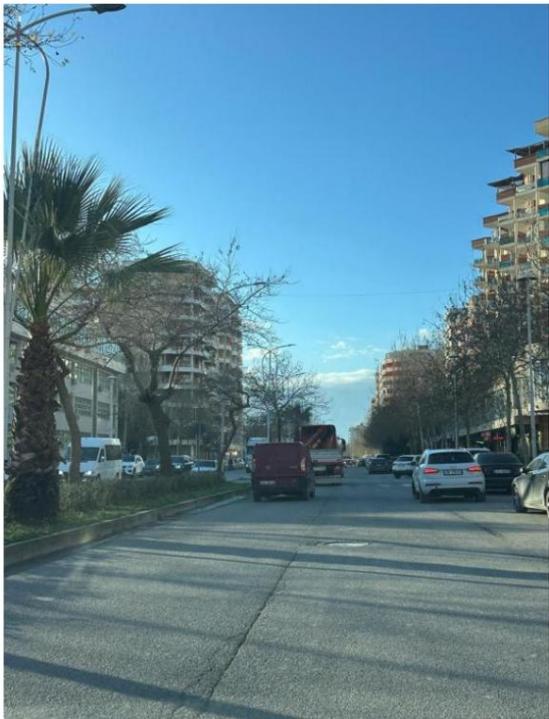
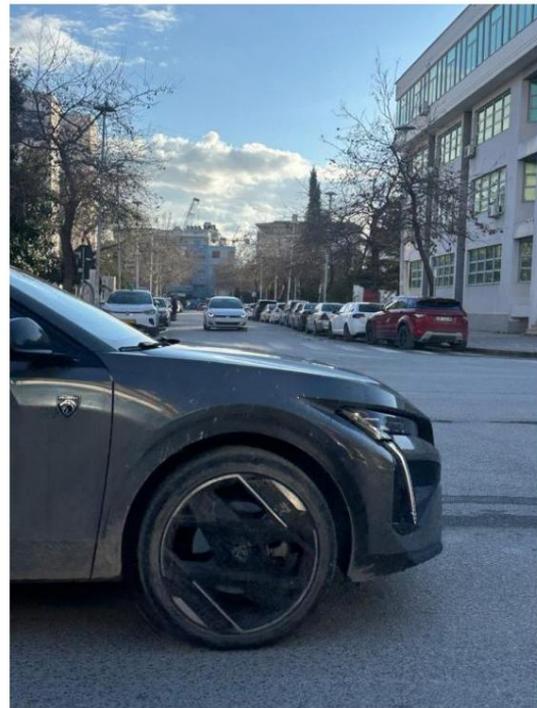
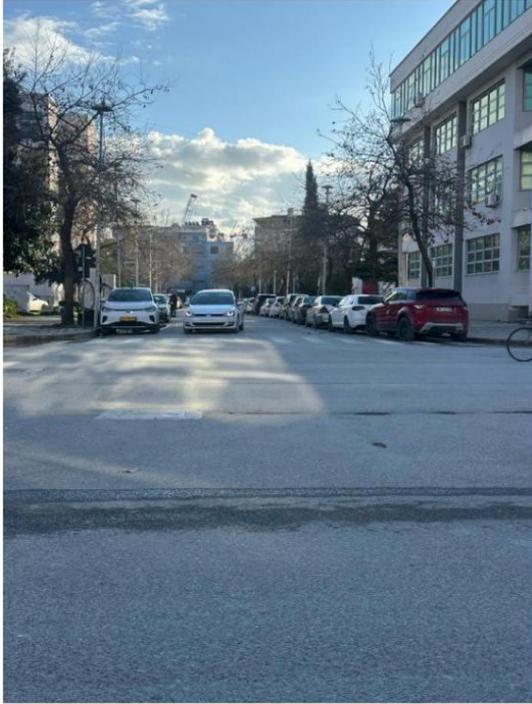
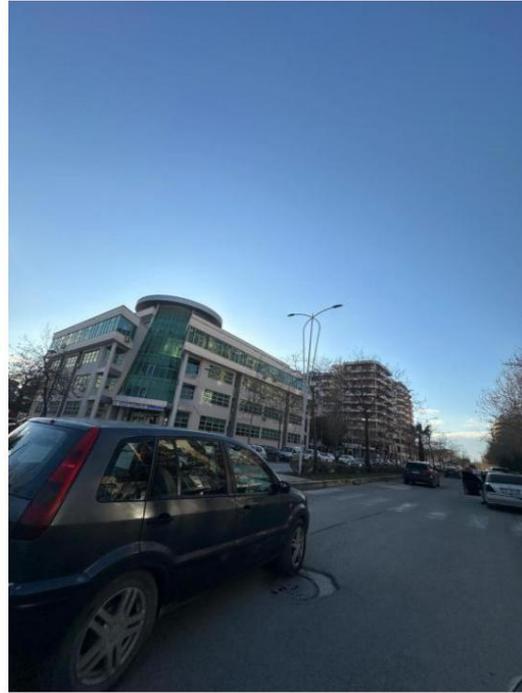
“KOSOVA” Street, 2 LANES

Photos of the existing condition.

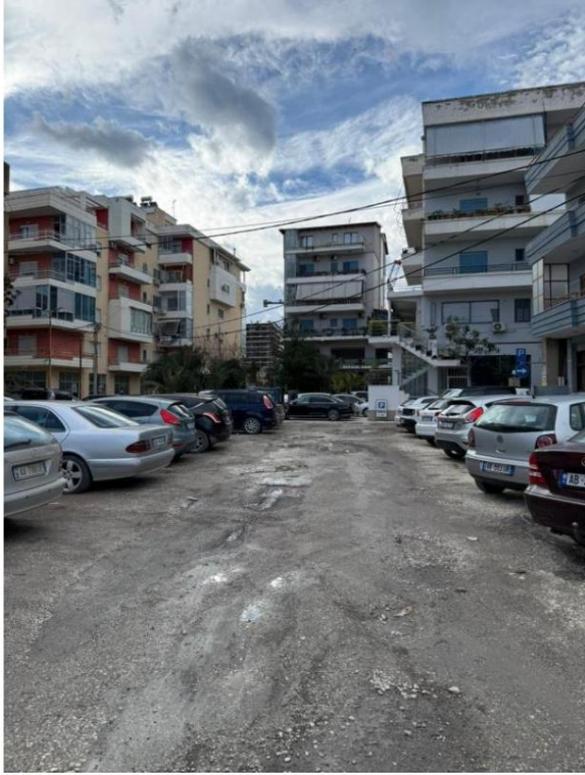
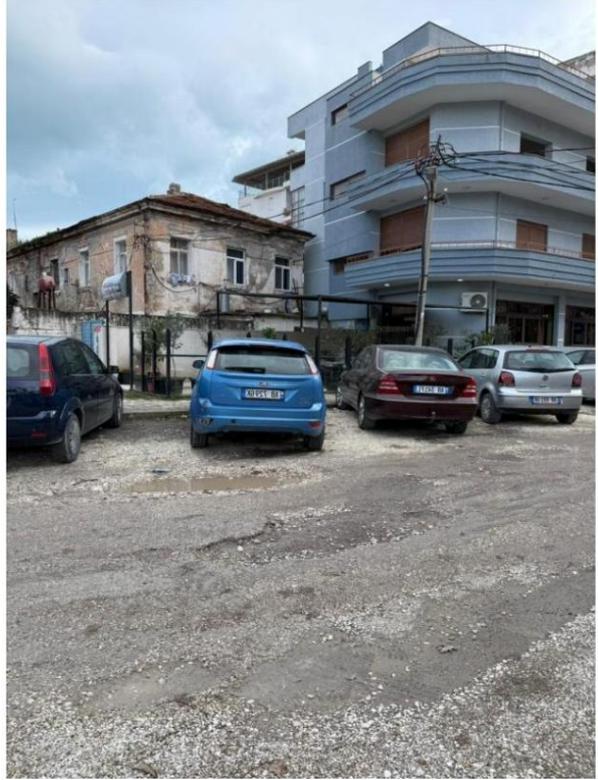
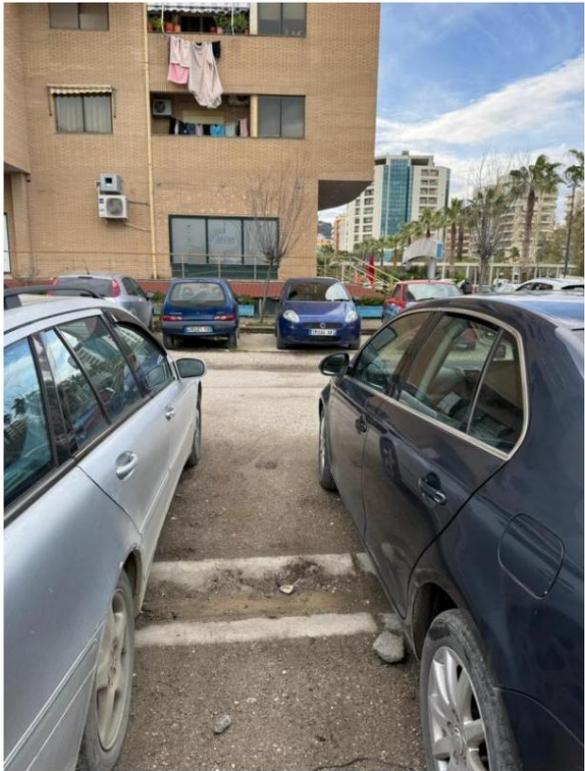
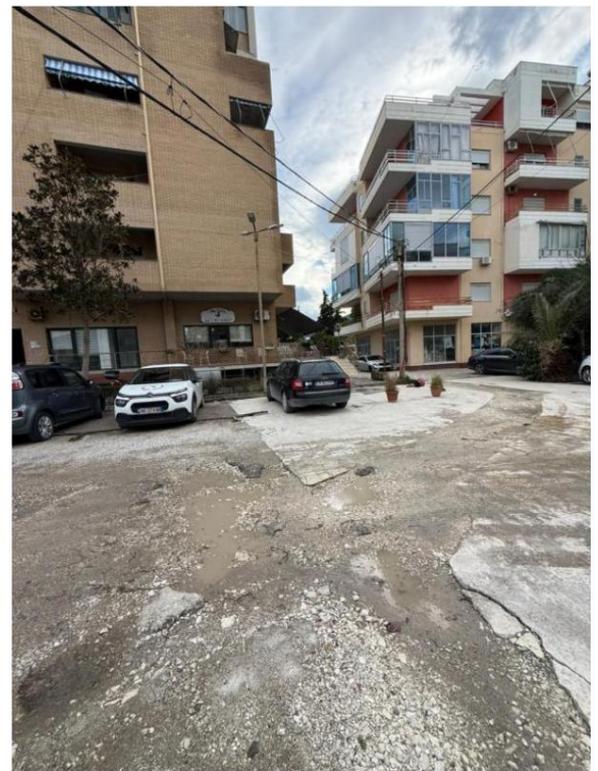
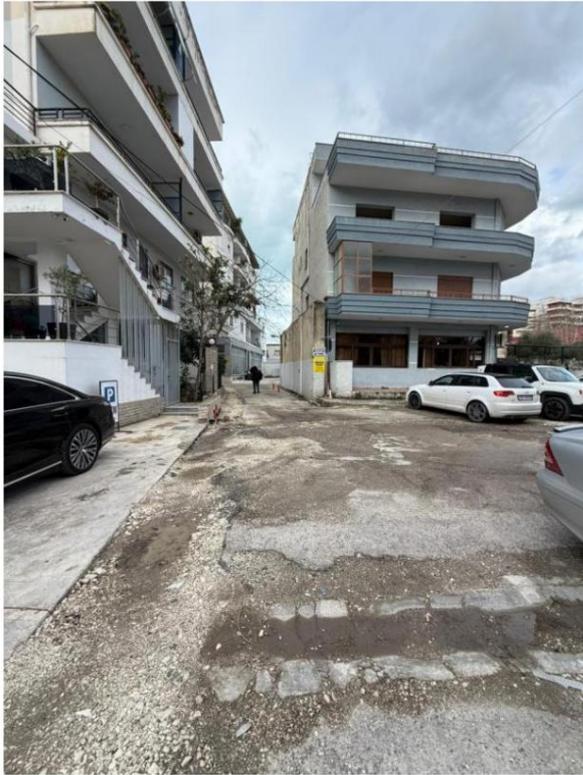
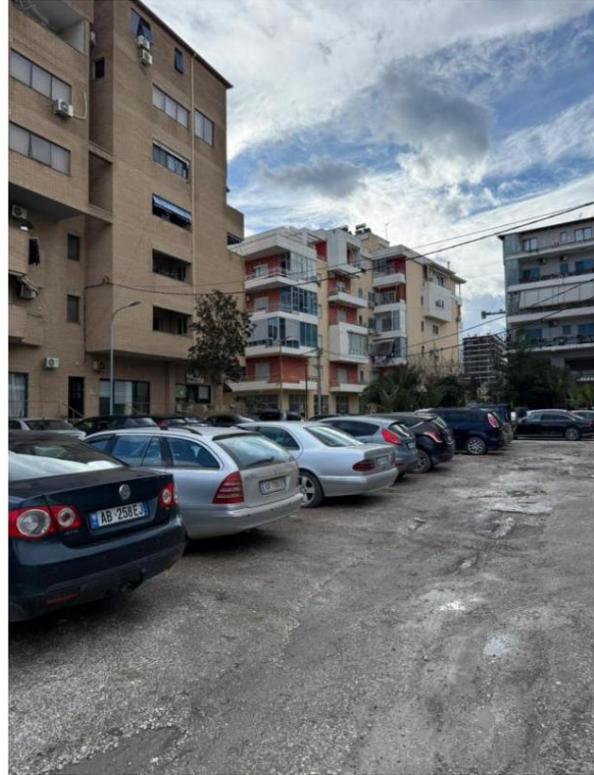
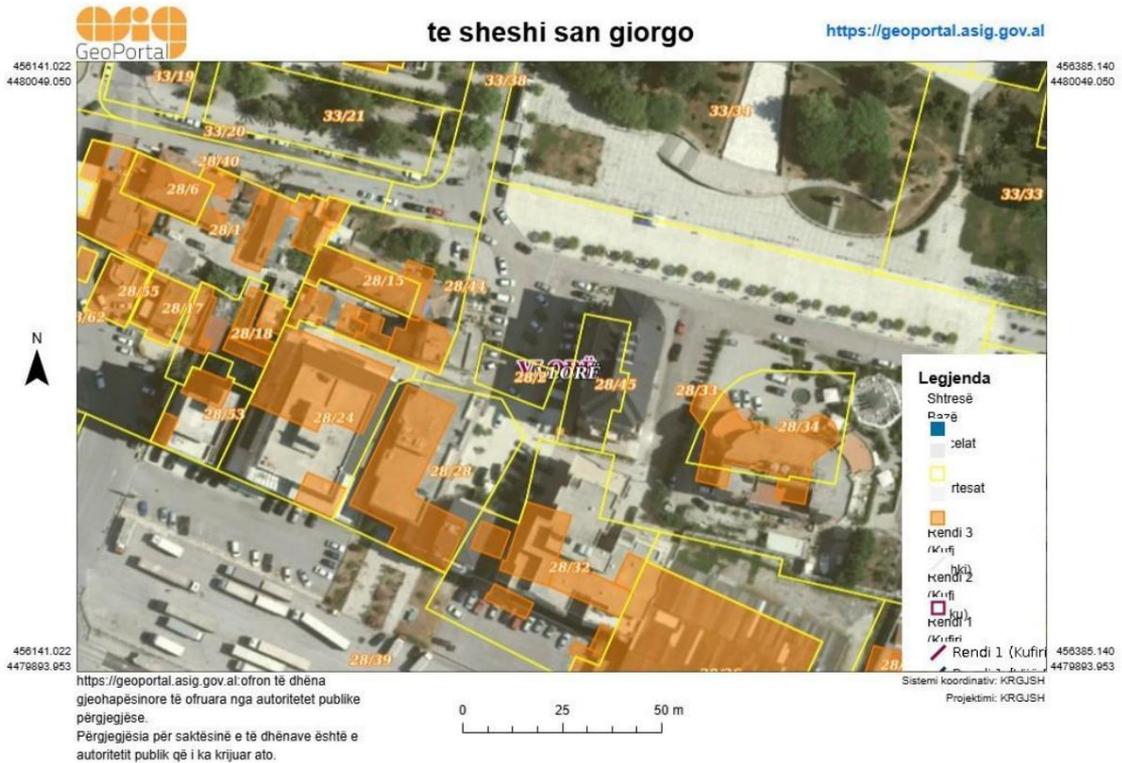
Parking at "San Giorgio", Region 2

The parking lot is unpaved and presents significant damage to the surface layer. Numerous potholes, surface deformations, gravel, and water puddles are observed due to the lack of regular drainage. This condition makes vehicle movement difficult and creates unsuitable conditions for circulation, especially during rainfall.

In its current state, the area does not meet minimum road and urban infrastructure standards.

Also verify whether a part of the parking lot is private property according to the horography.
