TECHNICAL REPORT (DESCRIPTIVE PROJECT)

Performance-based maintenance, Vorë - Maminas, Kamëz Turn - Vorë (parallel roads), Kamëz – Zall Herr – Bovillë, Road Intersection No. 52 – Prezë Castle, Gjolë Bridge – Bilaj, Bubq- Ishëm, Bërxullë - Domje, Bërxullë - Laknas (69.4 km), (Contract 1)

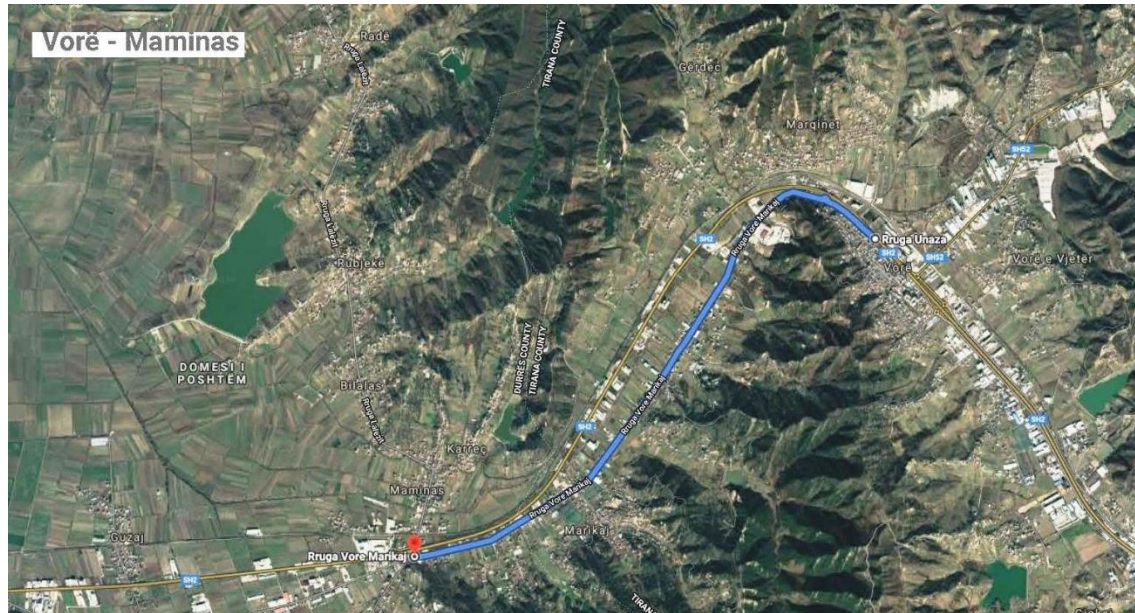
Vorë – Maminas

This road segment lies to the left side of Tiranë-Durrës highway, in a rural area.

The asphalt layers' conditions are good as they have been recently rehabilitated.

The side ditches and culverts need partial cleaning.

The road signs and safety need upgrade and partial replacements.

The road lies in a hilly terrain with one carriageway, without winter maintenance.

The required level of service is “good”.

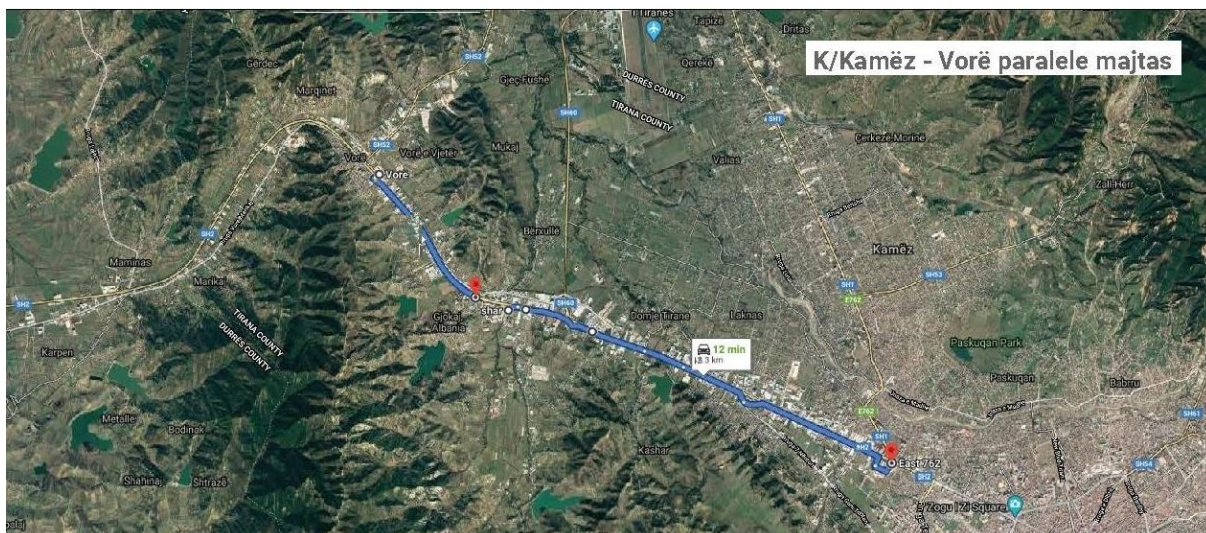
Kamëz Turn - Vorë (left parallel road)

This road segment lies to the left side of Tiranë-Durrës highway, in an industrial area.

The asphalt layers' conditions are good, but partial repairs are needed.

The side ditches and culverts need partial cleaning.

The road signs and safety need upgrade and partial replacements.

The required level of service is “good”.

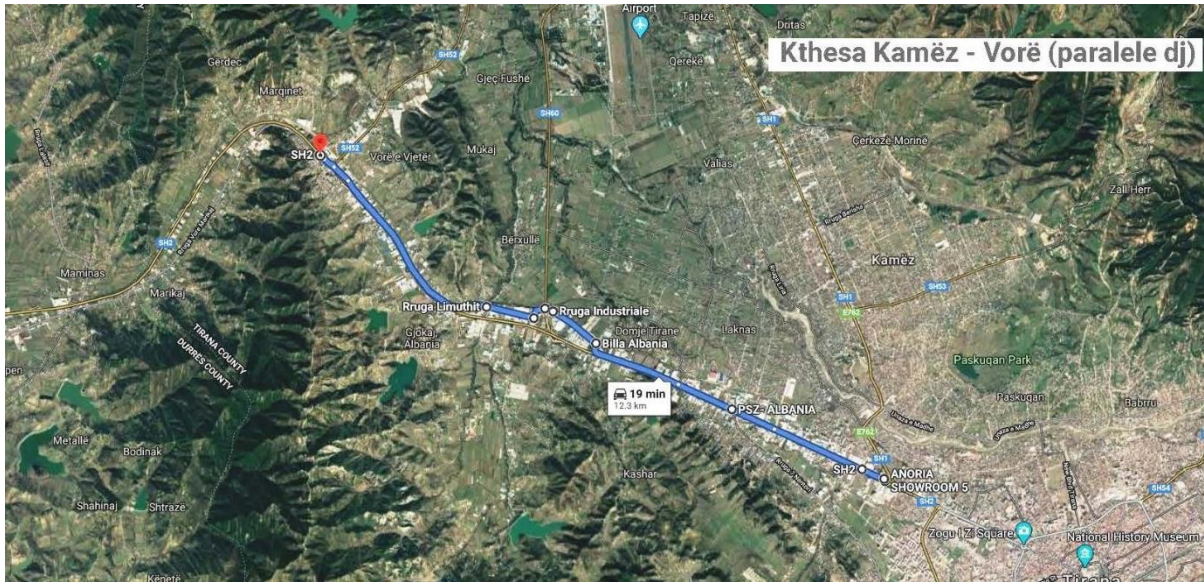
Kamëz Turn - Vorë (right parallel road)

This road segment lies to the right side of Tiranë-Durrës highway, in a rural area.
 It is a single carriageway segment.
 The asphalt layers' conditions are not good, and repairs are needed.
 The side ditches and culverts need partial cleaning.
 The road signs and safety need upgrade and partial replacements.
 The road lies in a hilly terrain with one carriageway, without winter maintenance.
 The required level of service is "good".

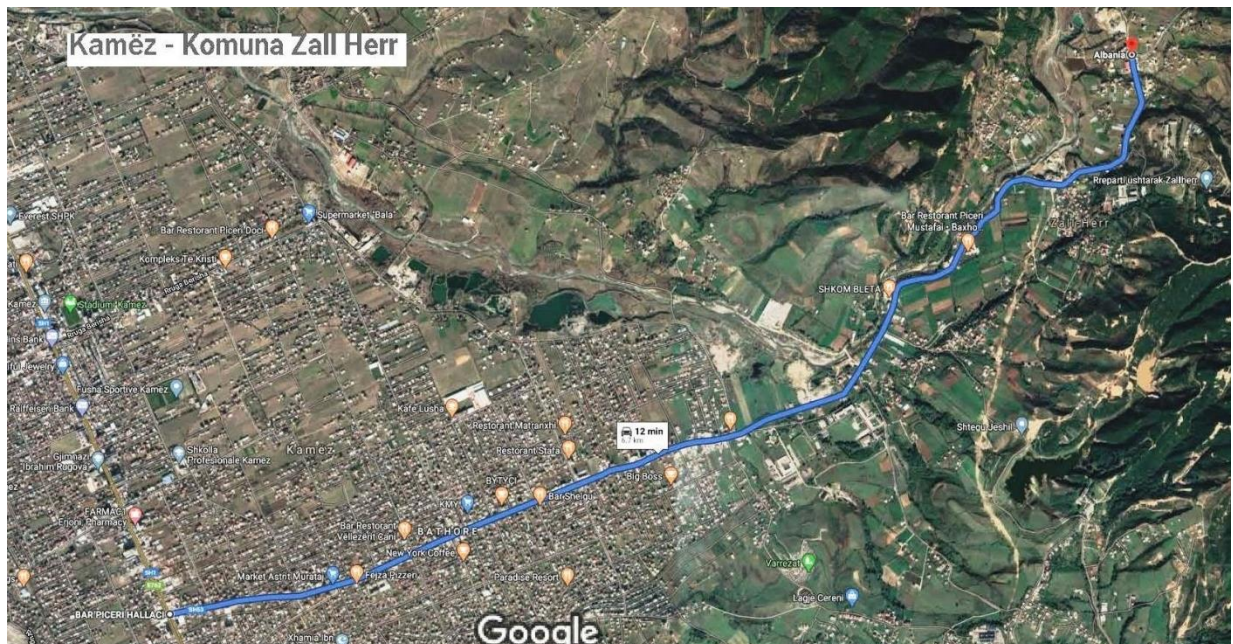
Kamëz - Zall Herr

This road segment is a right branch of the road no. 1. Tiranë-Hani i Hotit.
 It is a single carriageway segment.
 The asphalt layers' conditions are good.
 The side ditches and culverts need partial cleaning.
 The road signs and safety need upgrade and partial replacements.
 The road lies in a field terrain with one carriageway, without winter maintenance.
 The required level of service is "good".

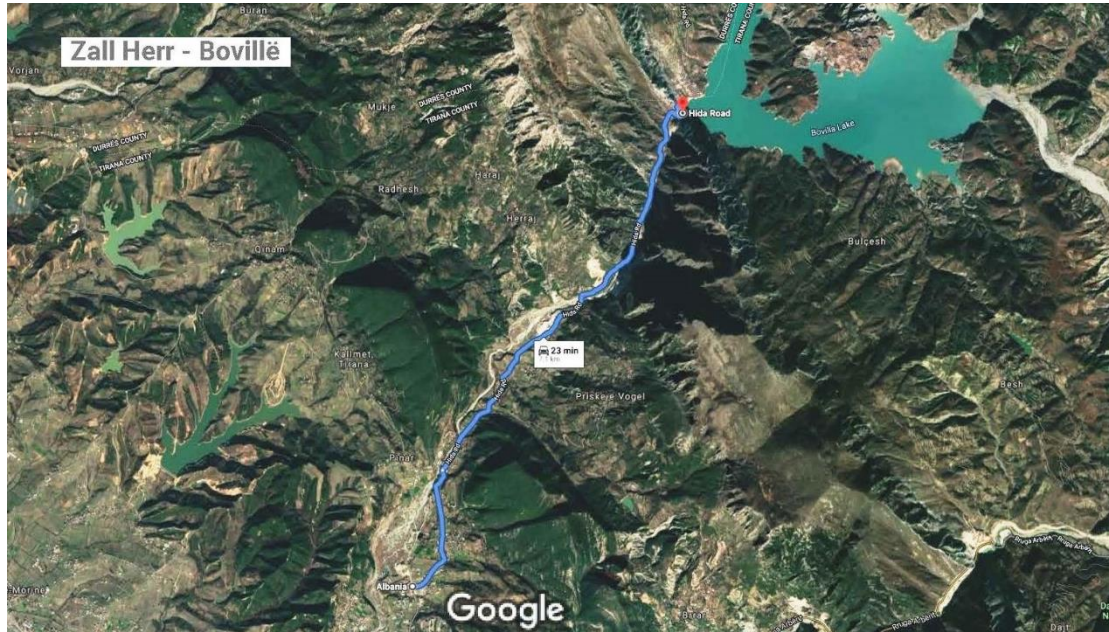
Zall Herr - Bovillë

It is a gravel-paved road, 4.5m wide.

The side ditches and culverts need cleaning.

The road signs and safety need upgrade and partial replacements.

The required level of service is “minimum”.

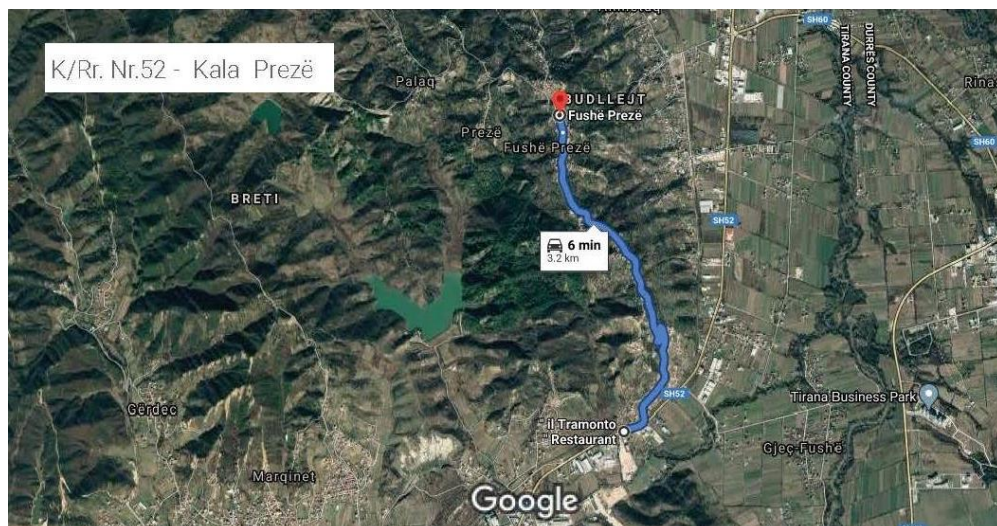
Road Intersection No.52 - Prezë Castle

This road segment is a right branch of the road no.52, Railroad Overpass Vorë - Exit of Overpass F. Krujë, in a rural area.

The asphalt layers' conditions are good.

The side ditches and culverts need partial cleaning.

The road signs and safety need upgrade and partial replacements.

The required level of service is “good”.

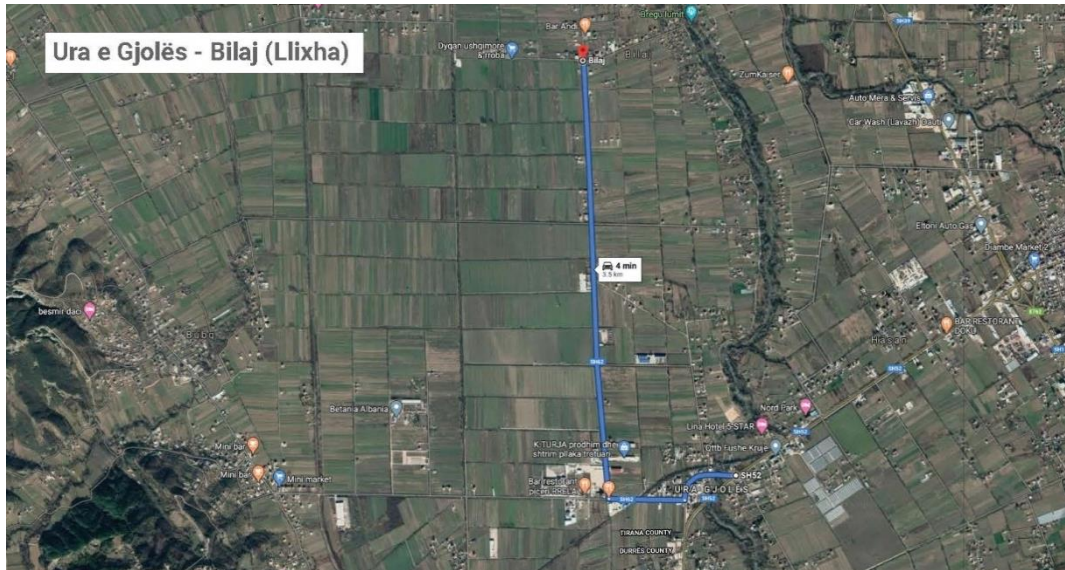
Gjolë Bridge - Bilaj (Llixha)

This road segment traverses Fushë Kruja city.

The asphalt layers' conditions are good.

The side ditches and culverts need partial cleaning.

The road signs and safety need upgrade and partial replacements.

The road lies in a field terrain with one carriageway, without winter maintenance, high risk.

The required level of service is "good".

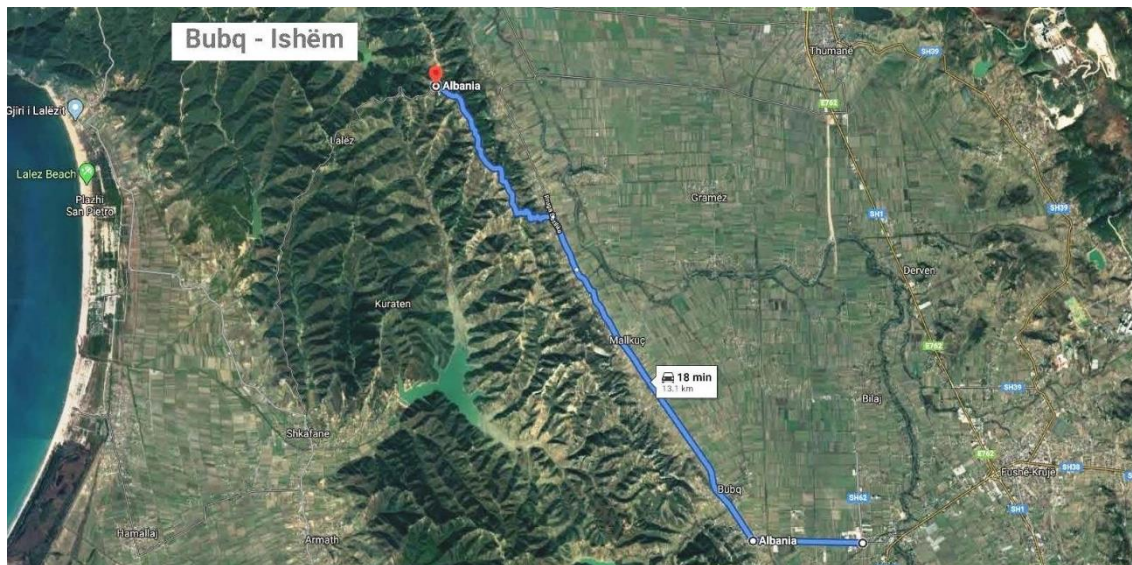
Bubq – Ishëm

This road segment is a right branch of road no. 1, Tiranë – Shkodër.

The asphalt layers' conditions are good, but minor repairs are needed.

The side ditches and culverts need partial cleaning.

The road signs and safety need upgrade and partial replacements.

The road lies in a field terrain with one carriageway, without winter maintenance, high risk.

The required level of service is "good".

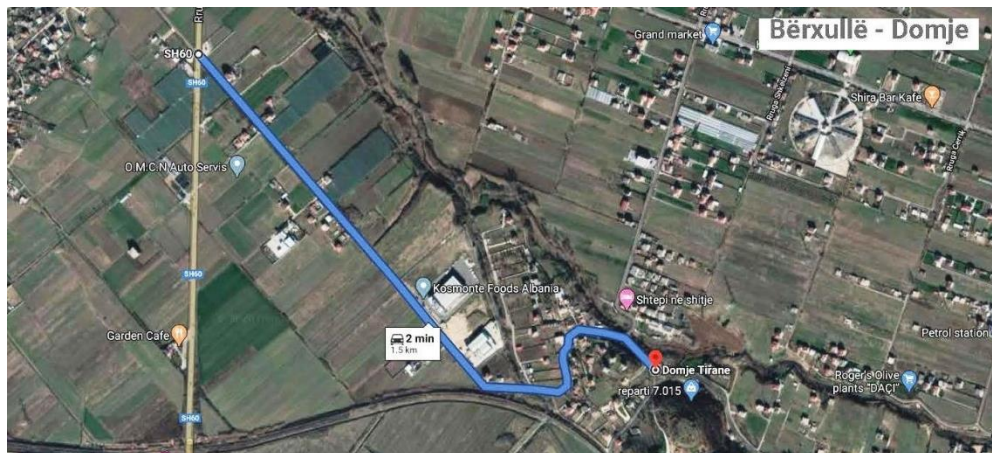
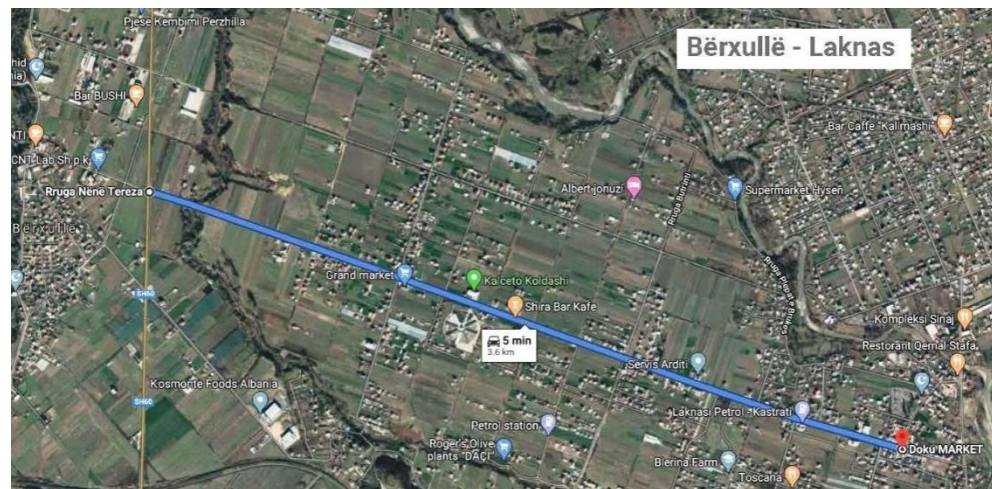
Bërçullë – Domje

Bërçullë – Laknas

These road segments are located to the right side of road no.60, Qafë Kashar - Rinas (Airport) across the rural area.

They are single carriageway segment.
 The asphalt layers' conditions are good.
 The side ditches and culverts need partial cleaning.
 The road signs and safety need upgrade and partial replacements.
 The road lies in a field terrain with one carriageway, without winter maintenance.
 The required level of service is "good".
