TECHNICAL REPORT (DESCRIPTIVE PROJECT)

Performance-based maintenance:

1. Levan – Vlorë (old) road segment 23,2 Km
2. Intersection Spital – Peshkëpi 10,5 Km
3. Peshkëpi – Selenicë 14,3 Km
4. Peshkëpi – Vllahinë 6,2 Km
5. Vllahinë – Poçëm – Povël 22,5 Km

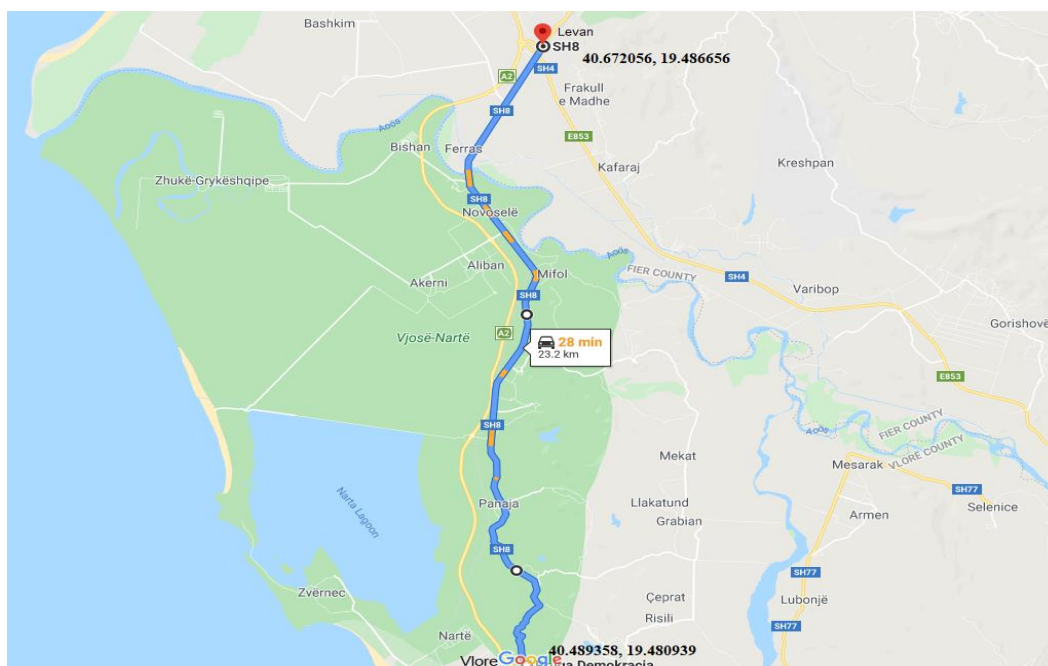
Levan – Vlorë (old) 23,2 Km

The asphalt layers' conditions are not good, so interventions are needed.

The side ditches and culverts need regular interventions.

The road signs and safety need the installation of horizontal signs (as provided for in the road code), as well as partial replacements and upgrades in the vertical signs.

The Mifoli Bridge located in this road segment is not equipped with parapets and its transversal weep holes and sidewalks are damaged; damages are also identified in the concrete protection layer of bridge retaining components.

The bridge in Ferras, built by Fier Municipality, requires the installation of guardrails and asphaltting.

The road lies in a field terrain with one carriageway, without winter maintenance, and it is prone to flooding by Vjosa River runoff.

The road failure in Bestrovës Pass is problematic.

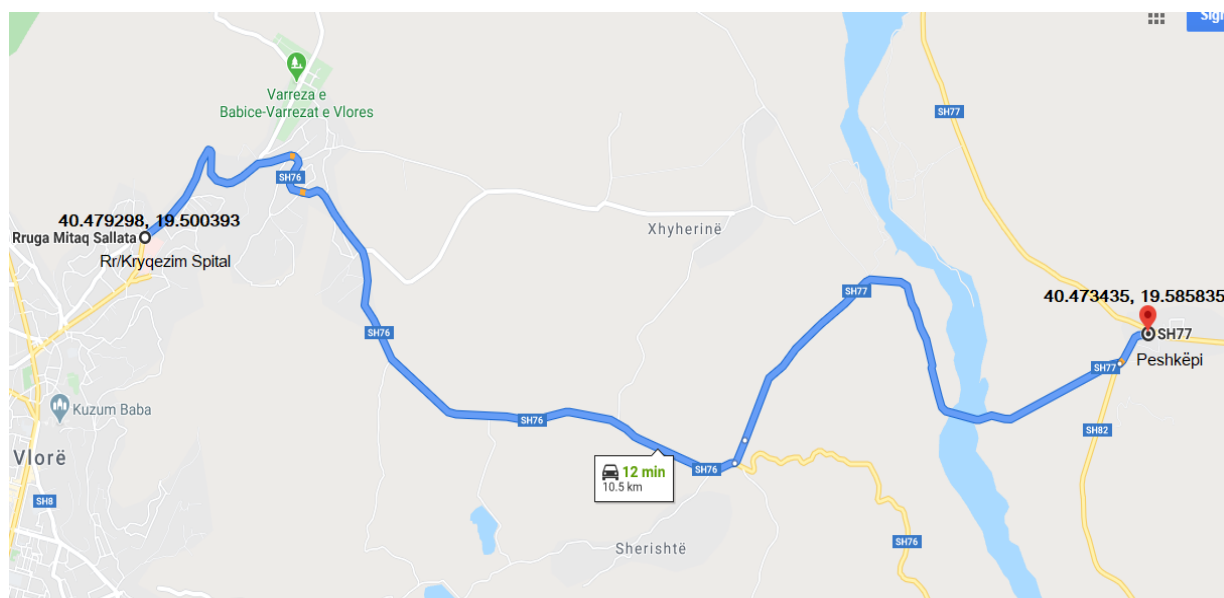
Intersection Spital (Vlorë) – Peshkëpi 10,5 Km

The asphalt layers' conditions up to Alikokë are not good, and asphalt pavement interventions are needed from the bridge near the hospital to Babicë e Madhe, divided into small segments. Once you leave Alikokë behind, the asphalt layers' conditions are very good, as it is a newly built road.

From the intersection Spital to Qafë Babicë there are some retaining walls that may fall or collapse.

The roadside ditches and art works need regular maintenance and cleaning.

The vertical road signs need upgrade, and the road signs in general should be installed in the right time, as set forth in technical conditions.

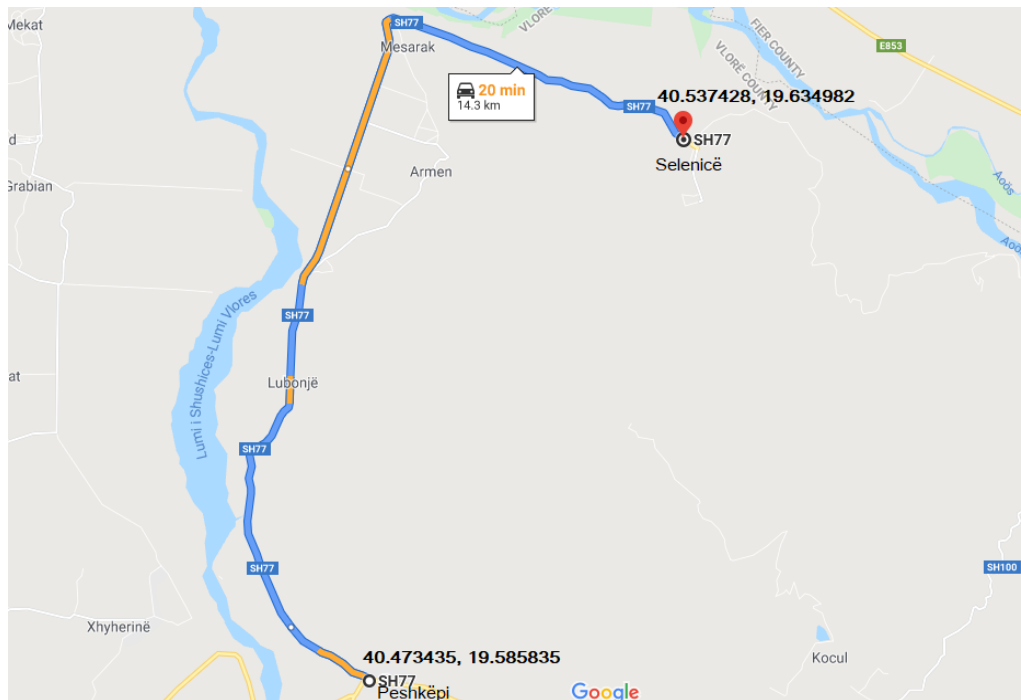
Peshkëpi – Selenicë 14,3 Km

The asphalt layers' conditions are not optimal, and regular interventions are needed (Lubonjë, Bishti i Malit, Armen).

The roadside ditches and art works need regular interventions.

Vegetation grows fast after being cut because of water presence.

The vertical road signs need upgrade and partial replacements, whereas the horizontal road signs should be installed in the right time, as set forth in technical conditions.

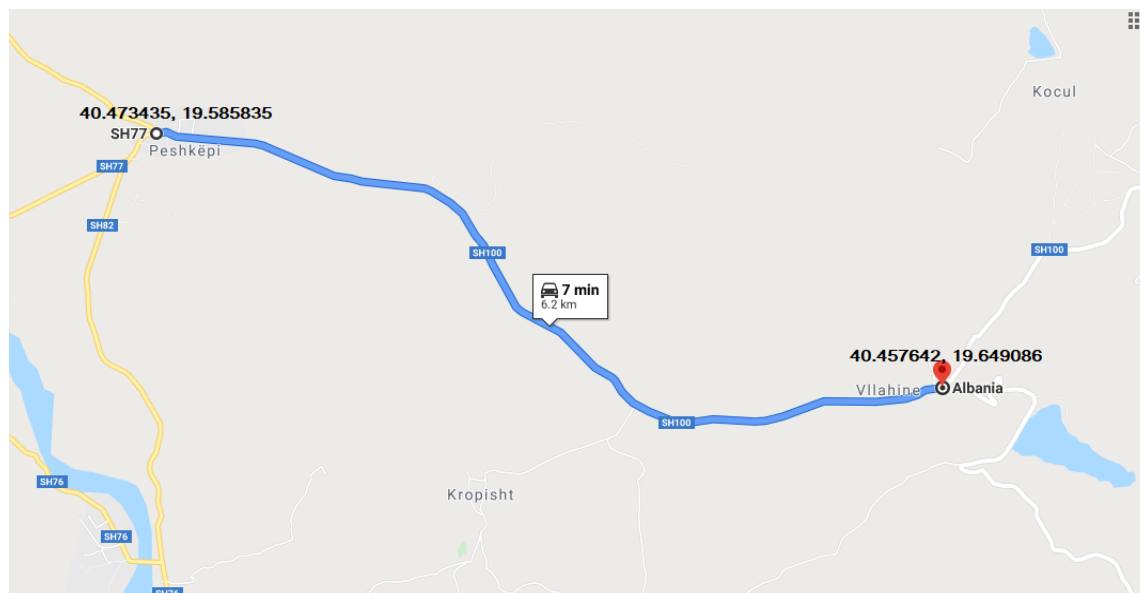
Peshkëpi – Vllahinë 6,2 Km

The asphalt layers' conditions are relatively good. Maintenance is needed to maintain current conditions.

Another problem is the merge to the exit of Peshkëpi, namely the former oil-related repair shop, where the road narrows to single lane; the vertical road signs are the right ones.

Gravel road, not in good conditions.

The roadside ditches and art works need cleaning and minor repairs.

The shoulders' conditions are not good and ongoing maintenance is needed, because vegetation grows fast.

The vertical road signs need upgrade and regular road marking lines is required.

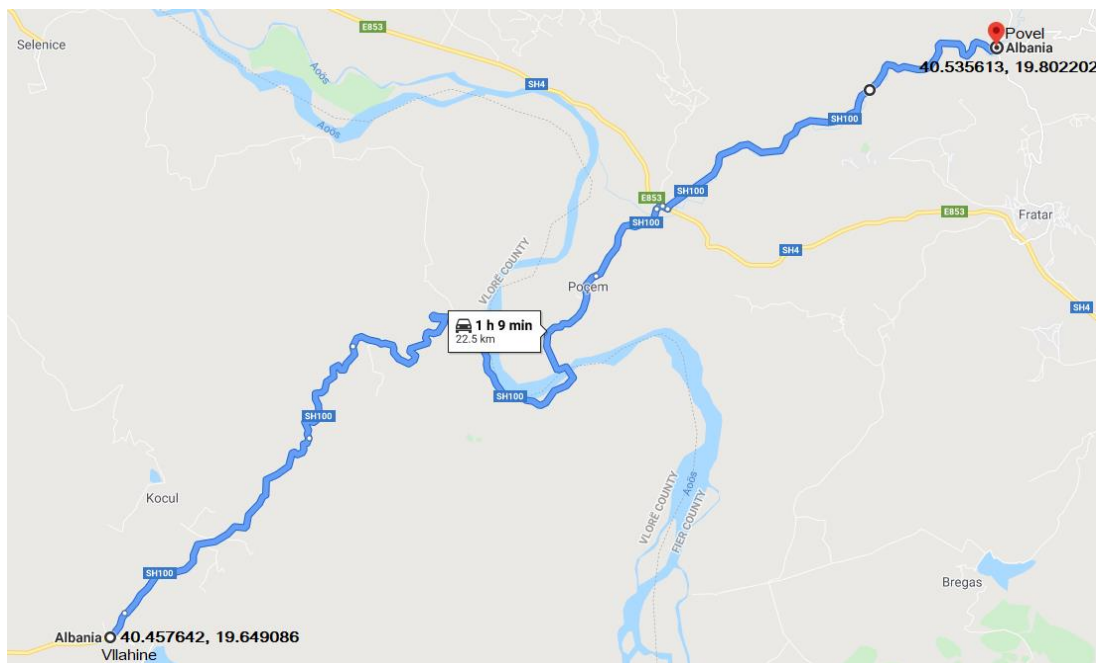
Vllahinë – Poçëm – Povël 22,5 Km

The road segment is gravel-paved, no asphalt layers. Its slopes are composed of tuff formation, geologically not matured, with major damages to road track and art works from Vllahina to Gorrisht.

There is another problem related to art works in the vicinity of Karbunar village, in a bridge where one of its abutments has failed. This road is also used by oil tanker trucks going to Gorrisht, which is the center for their oil supply.

The roadside ditches and shoulders require permanent maintenance because of the terrain characteristics.

The road grades will always face problems, so large volumes of gravel are needed.

The road signs require upgrade and replacement. Only vertical road signs are available.
