TECHNICAL REPORT

Contract: Performance-based maintenance, Kthese Patos - Ballsh road + Ballsh-Fratar(Mallakaster) road + Ballsh - Aranitas road + Metohasim – Kafaraj (K/Frakull-Kashishte) road + K/Rr Nazionale – Bylis road 61.4 km

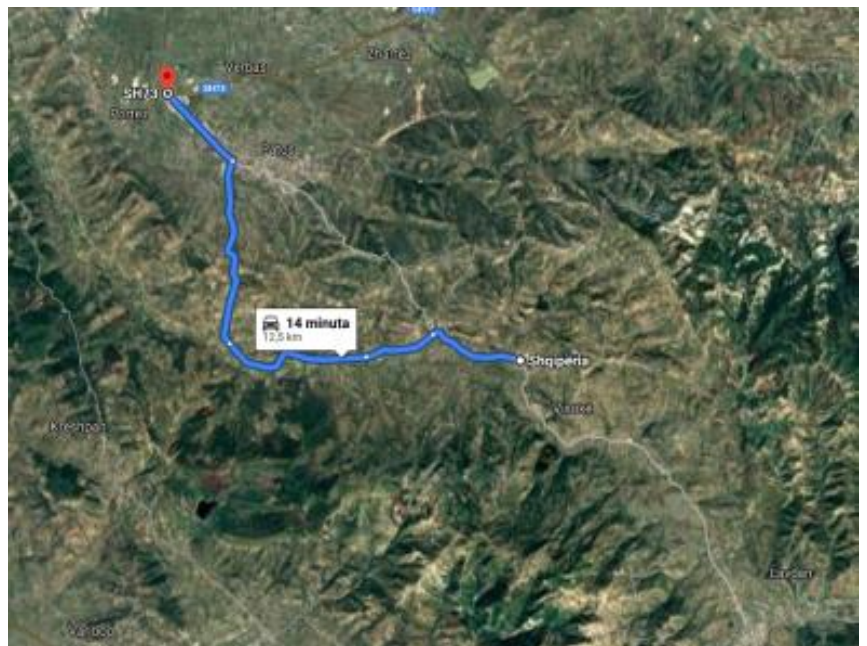
Fier(kthese Patosi) - Visoke (old repair shop)

The asphalt layers are amortized because of heavy vehicles movement, which transport oil and solid materials to Mallakaster, so regular monitoring is required.

The side ditches and culverts need partial cleaning.

The concrete arches in some bridges and culverts should be repaired.

The road signs and safety need upgrade and partial replacements.

Due to the terrain, escarpments from km 13 -15 are not stable, and they should be regularly monitored.

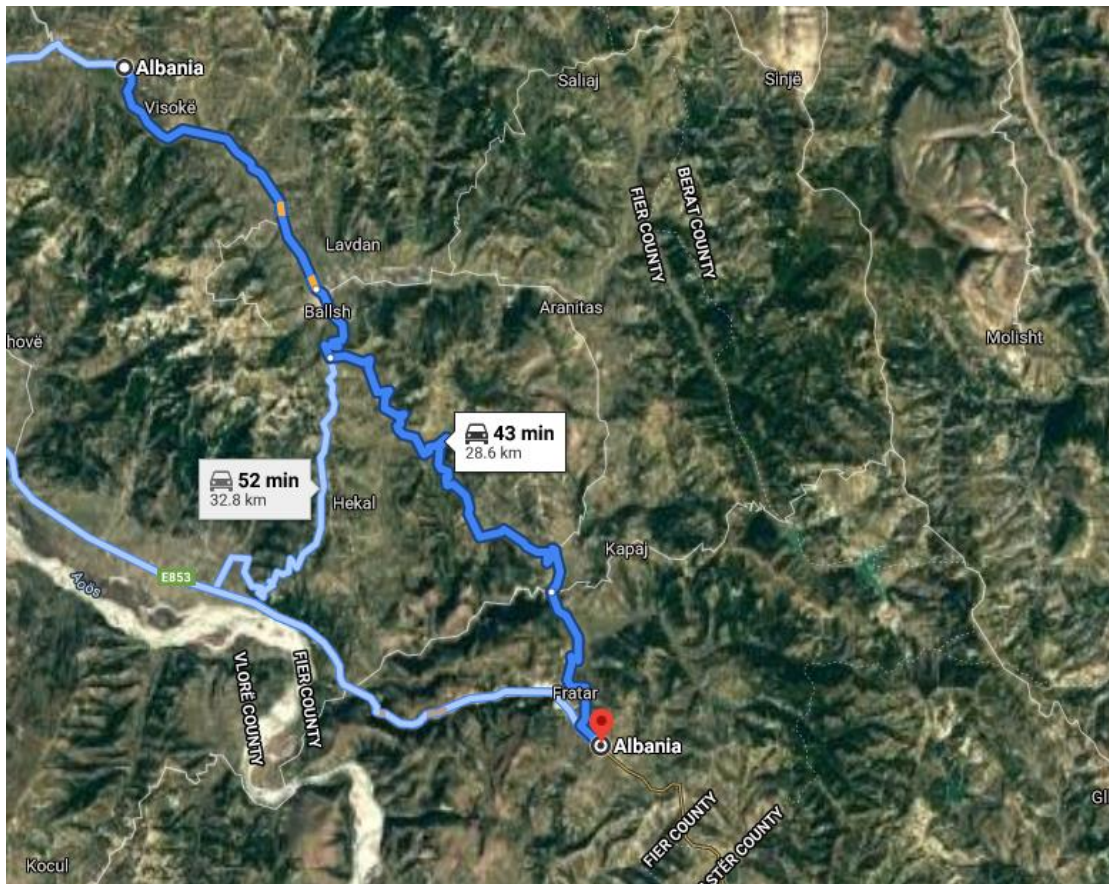
Visoke-Fratar(Mallakaster) road

The asphalt layers are too amortized because of heavy vehicles movement, which transport oil and solid materials to Mallakaster, so regular monitoring is required.

The roadside ditches and culverts need regular cleaning because of rough terrain and the presence of landslides and rock falling during rainfalls.

The concrete arches in some bridges and culverts should be repaired..

The road signs and safety need upgrade and partial replacements.

The frequent slides in the entire road length are another problem requiring interventions.

1-Slides are present about 50 m to Ballsh exit, in km 11.8 to the left side, which is highly problematic during winter time. Its solution is to build retaining walls, which can prevent landslides.

2-Slides are present in km 11.6, to the left side, 50 m from Qafe Kashi

3-Slides are present about 100 m in km 12.2, behind the bar in water storage facility, to the right side. The road has been narrowed as a result of such slides (its width is reduced to 4m).

4-Slides are present about 20 m in Kojlac reservoir, in km 12.6.

5-Slides are present about 20 m to the right side, in km 13.1.

6-Slides are present about 25 m, in km 13.4.

7-Slides are present about 30 m in Qafe e Sykuqit, to the right side, in km 16.1

8-Slides are present about 30 m near the sharp turn behind the guardrails in km 16.5

Major failures in sharp turns in Greshice in km 20, for about 200 m.

9-Slides are present about 100 m in Greshice close to Povel, km 21.9

10-Slides are present about 200 m, in km 22.2.

11-Slides are present about 100 m, from km 22.6 to km 22.8, near the sharp turn descending to Povel.

12-Slides are present about 30 m, in km 23, and major failures identified

13-Slides are present about 200 m in the gravel-paved section, before reaching the slide in Povle, in km 23.7

14-Slides are present about 100 before reaching Povle Bridge, in km 24; the road has been narrowed to a width of 2.5 m

15-Slides are present about 65 m, in km 24 .9; the road has been narrowed to a width of 3 m

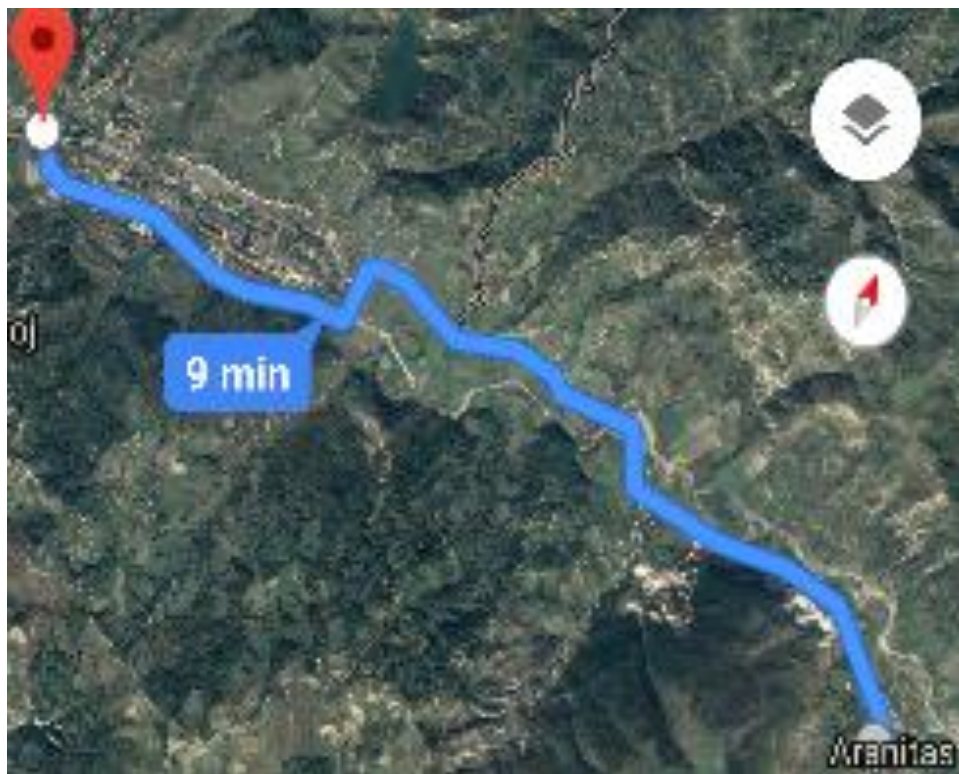
Ballsh-Aranitas

The conditions of bridges and culverts are good, except for the bridge in km 3.8 where the stone wall has been damaged (Panahori exit).

The movement of heavy vehicles transporting oil and solid materials to Aranitas remains a problem.

The asphalt layers' conditions are generally good, but surface course interventions are needed in km 5.5-6 because of road cracks and failures.

The side ditches and culverts need regular cleaning.

The road signs and safety need upgrade and partial replacements.

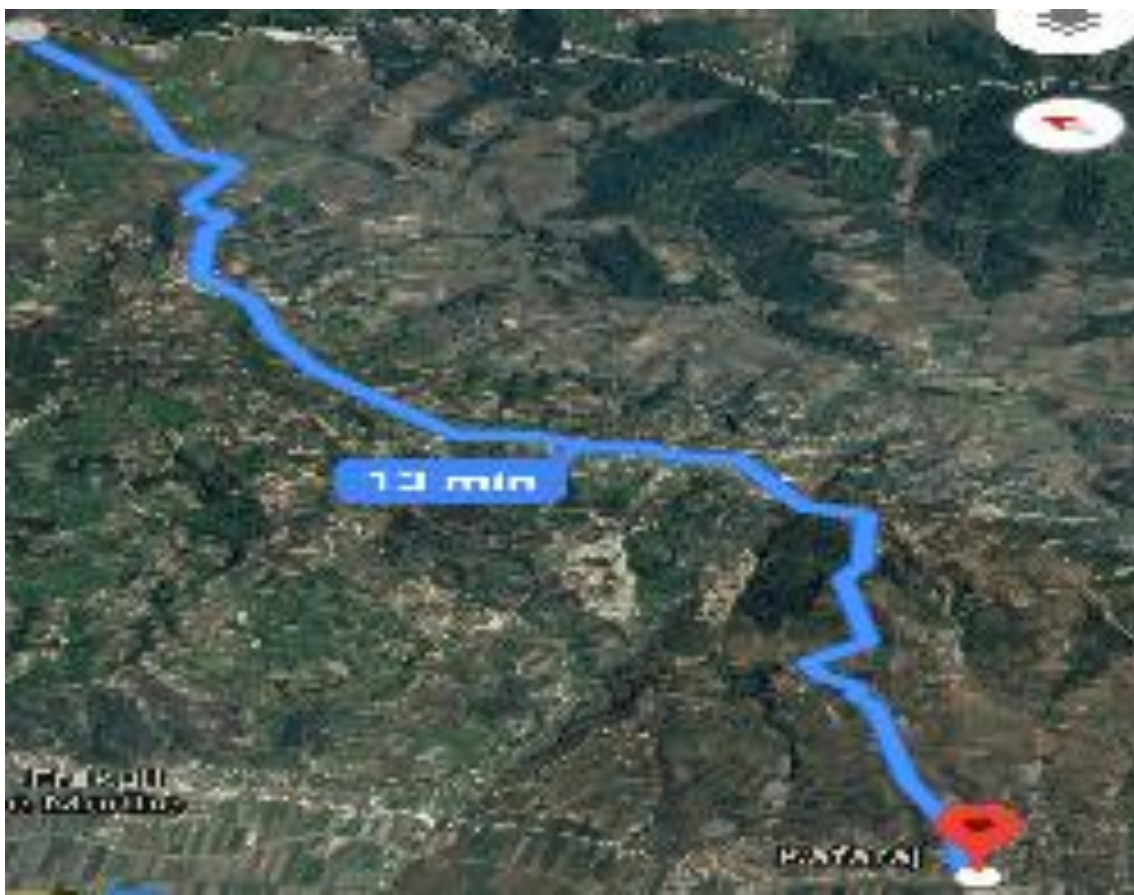
Metohasim – Kafaraj (K/Frakull – Kashisht) road

The asphalt layers' conditions are good, but minor repairs are needed.

The roadside ditches, culverts and gutters need regular cleaning because of the presence of alluvium during rainfalls.

The road signs and safety need upgrade and partial replacements.

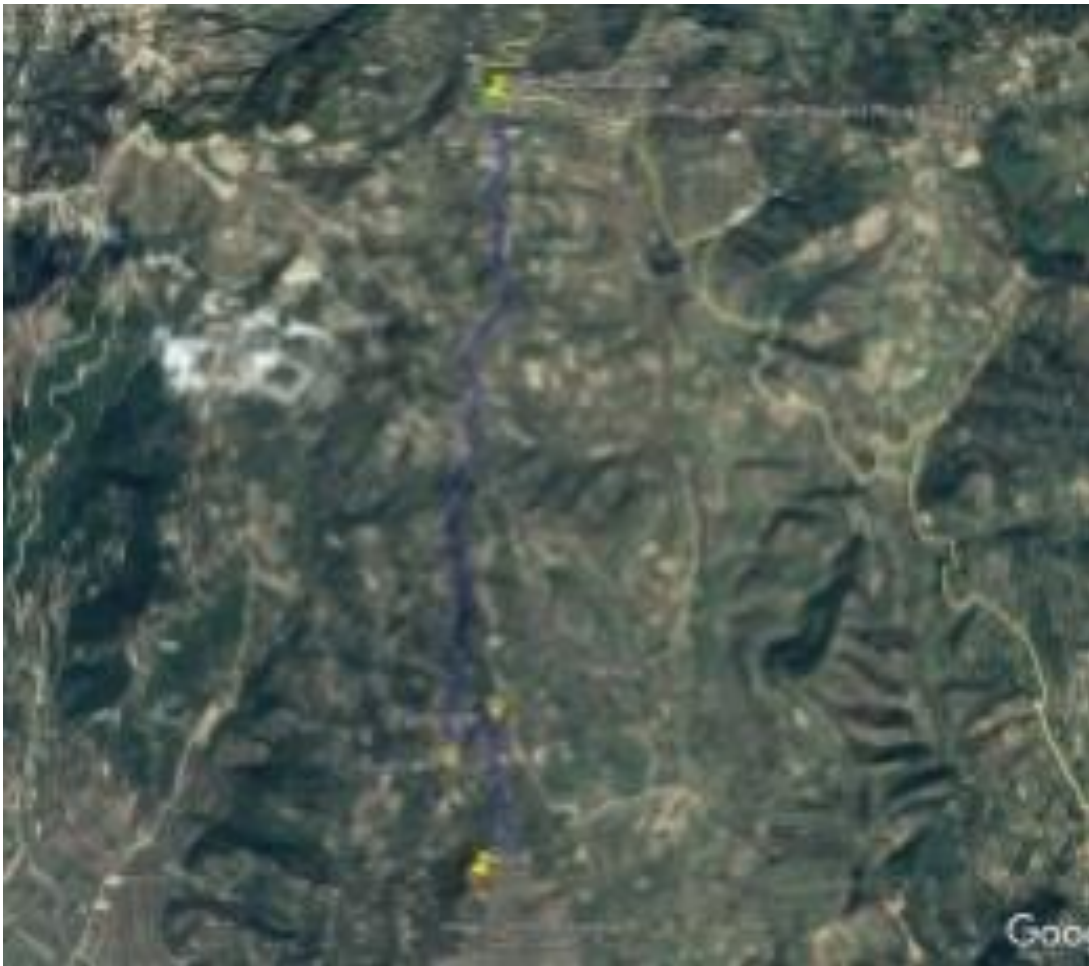
Rr.Kryq.Rruga Nationale-Bylis

The side ditches and culverts need regular cleaning.

The road signs and safety need upgrade and partial replacements.

Road failures are identified close to the 100 m long landslide in km 1.7, which require interventions to turn it within normal conditions.

A problem to this road axis is the 100 m landslide in km 2.2-2.3, to the left and right sides, which has resulted in retaining wall cracks, and interventions are required to turn it within normal conditions.

There is a 25m road failure in km 3.9, which requires interventions to fix it.
