## TECHNICAL REPORT (DESCRIPTIVE REPORT)

Performance-based routine maintenance, "Q.Laç - Koman, H/Berdice- Velipojë, Buna Bridge (new)-Shirokë, Krye Bushat-B.Jugë, D/Barbullush-Kukël" 81.1 km

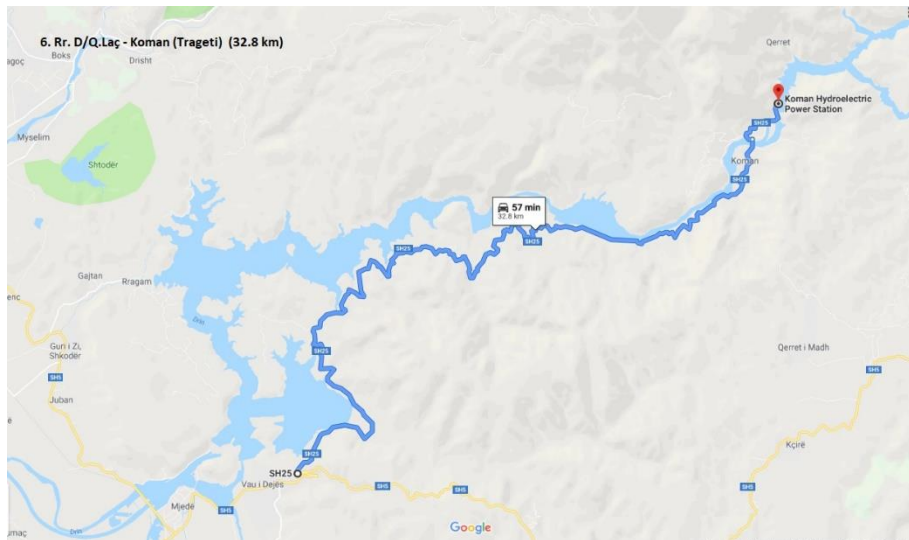
**Q. Laç – Koman 32.8 km**

It is a paved segment with one carriageway (width 6 ml).

The asphalt layers' conditions are poor. Despite the partial interventions carried out under previous maintenance contracts, this road axis needs a total reconstruction.

The side ditches and culverts need partial cleaning.

The road signs and safety need further completion and ongoing maintenance.

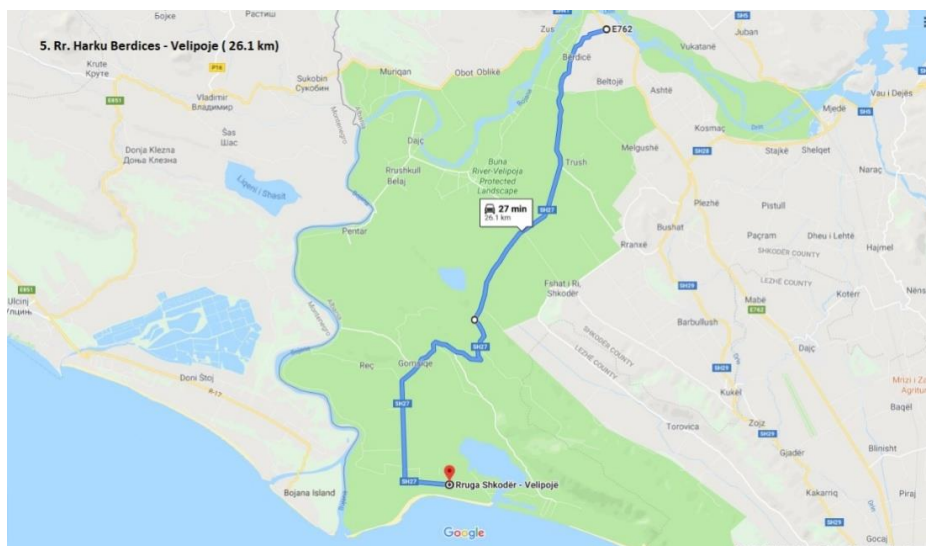
### **Harku Bërdicës– Velipojë 26.1 km**

It is a paved segment with one carriageway (width 6 -7 ml)

The asphalt layers' conditions are poor in the first 3.5 km. The conditions of the rest are good.

The side ditches and culverts need partial cleaning.

The road signs and safety need further completion in the first 3.5 km, whereas the rest needs ongoing maintenance

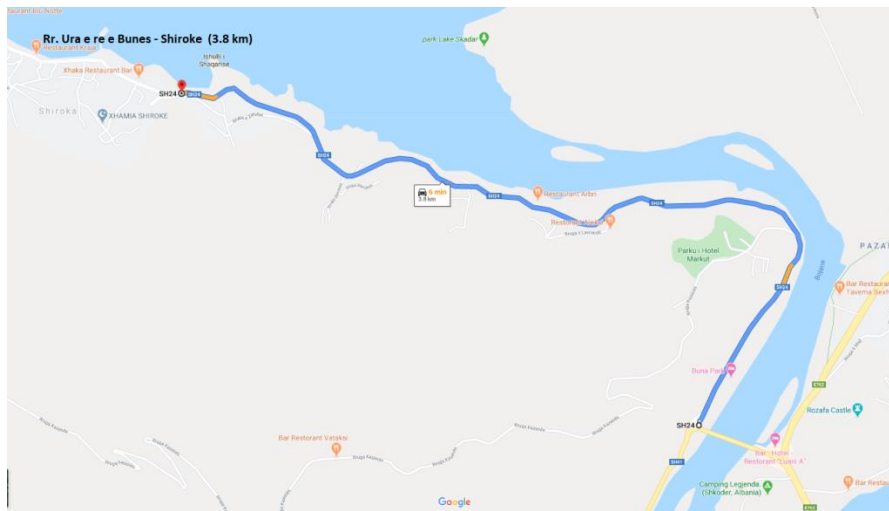
### **(New) Buna Bridge - Shirokë 3.8 km**

The asphalt layers' conditions are good.

The side ditches and culverts need partial cleaning.

The road signs and safety need ongoing maintenance.  
The road lies in a hilly terrain and is not subject to winter maintenance.  
The required level of service is “good”.

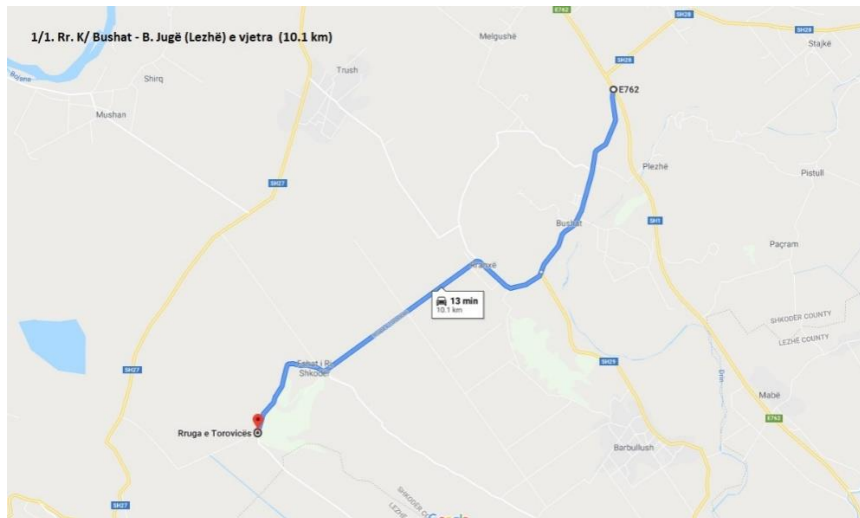
#### **K/Bushat - Bisht Jugë 10.1 km**

It is a paved segment with one carriageway (width 6 ml,  
The asphalt layers' conditions are good.  
The side ditches and culverts need partial cleaning.  
The road signs and safety need ongoing maintenance.  
The road lies in a field terrain and is not subject to winter maintenance.  
The required level of service is “good”.

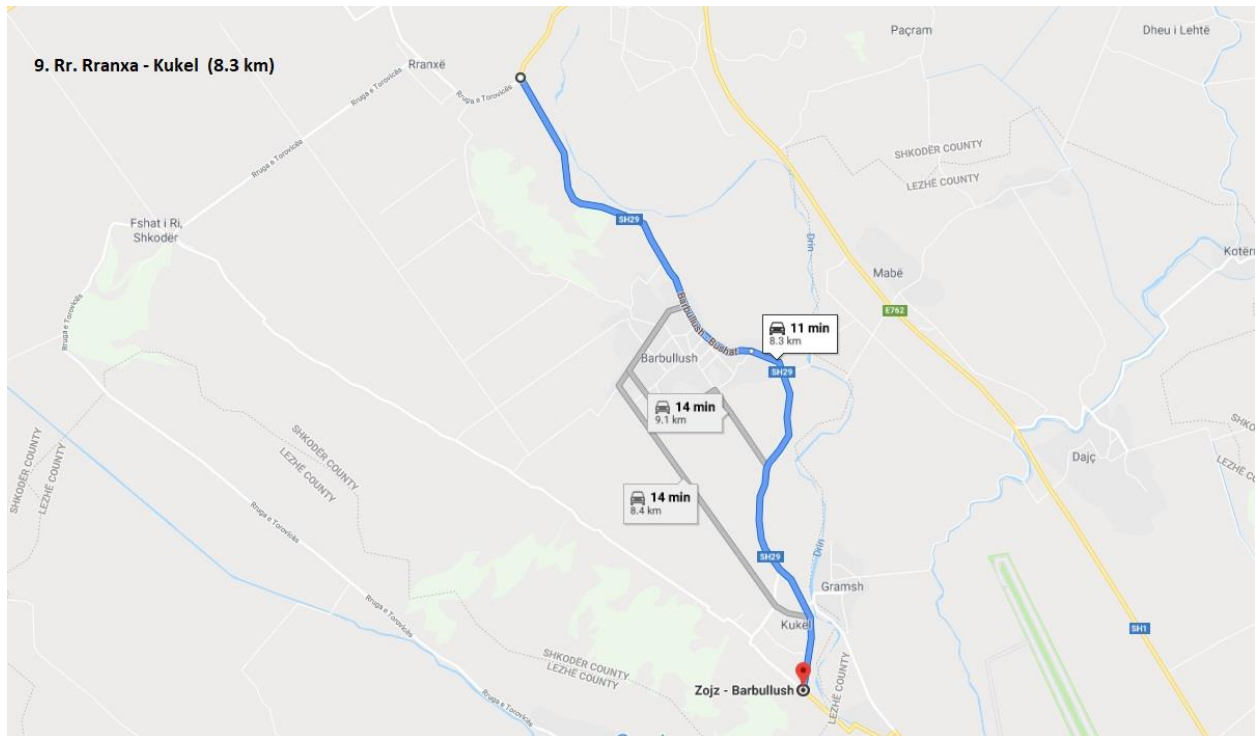
#### **D/Barbullush - Kukel 8.3 km**

This road segment is part of road no. 29.  
It is a paved segment with one carriageway (width 5 ml,  
The asphalt layers' conditions are good.  
The side ditches and culverts need partial cleaning.  
The road signs and safety need ongoing maintenance.  
The road lies in a field terrain and is not subject to winter maintenance.
