## TECHNICAL REPORT (DESCRIPTIVE REPORT)

Performance-based routine maintenance “B.Curri - Valbonë, Bujan Bridge - Morina Pass (customs), Sopot-Kernajë, Meidan Pass - Tropoje - Bucaj” 59.3 km

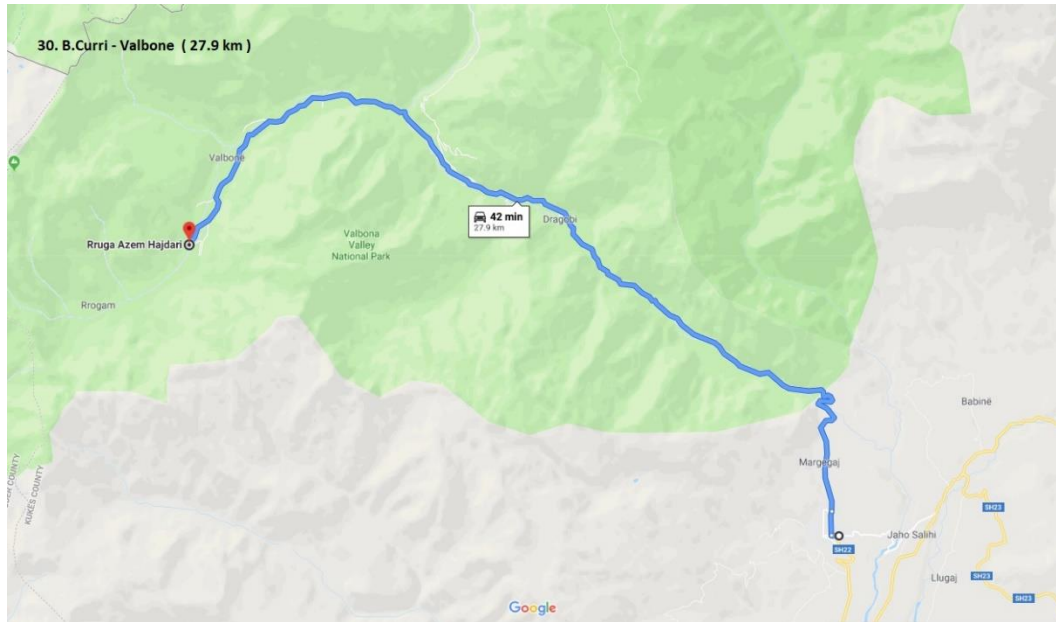
**B.Curri - Valbonë 27.9 km**

It is a paved segment with one carriageway (width 6 ml).

The asphalt layers' conditions are averagely good.

The side ditches and culverts need partial cleaning.

The road signs and safety need further completion and ongoing maintenance.

The road lies in a highly mountainous terrain and is subject to winter maintenance.

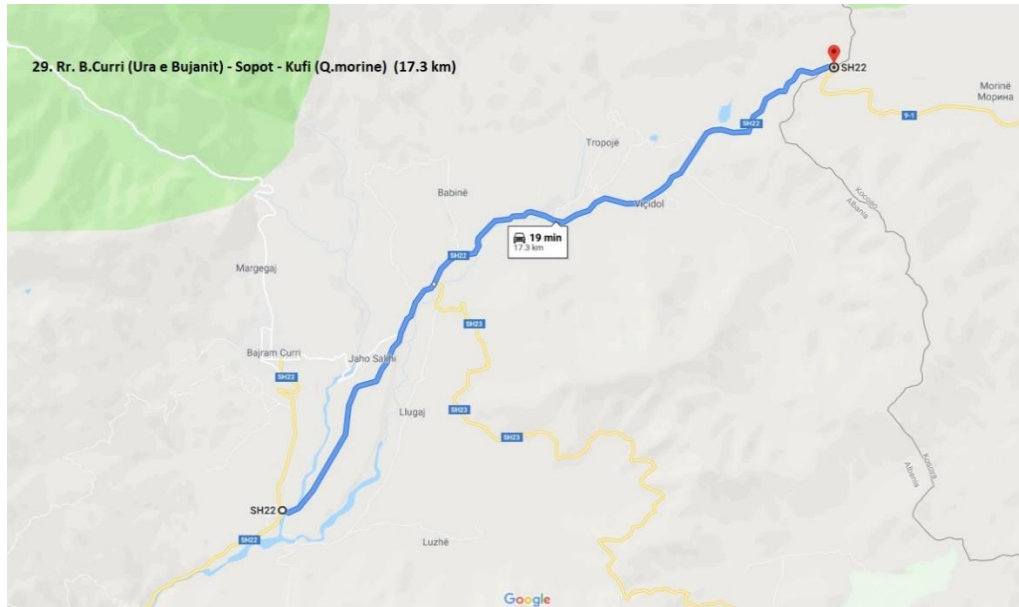
**Bujan Bridge - Morina Pass (customs) 17.3 km**

It is a paved segment with one carriageway (width 6 ml).

The asphalt layers' conditions are averagely good.

The side ditches and culverts need partial cleaning.

The road signs and safety need further completion and ongoing maintenance.

The road lies in a mountainous terrain and is subject to winter maintenance.

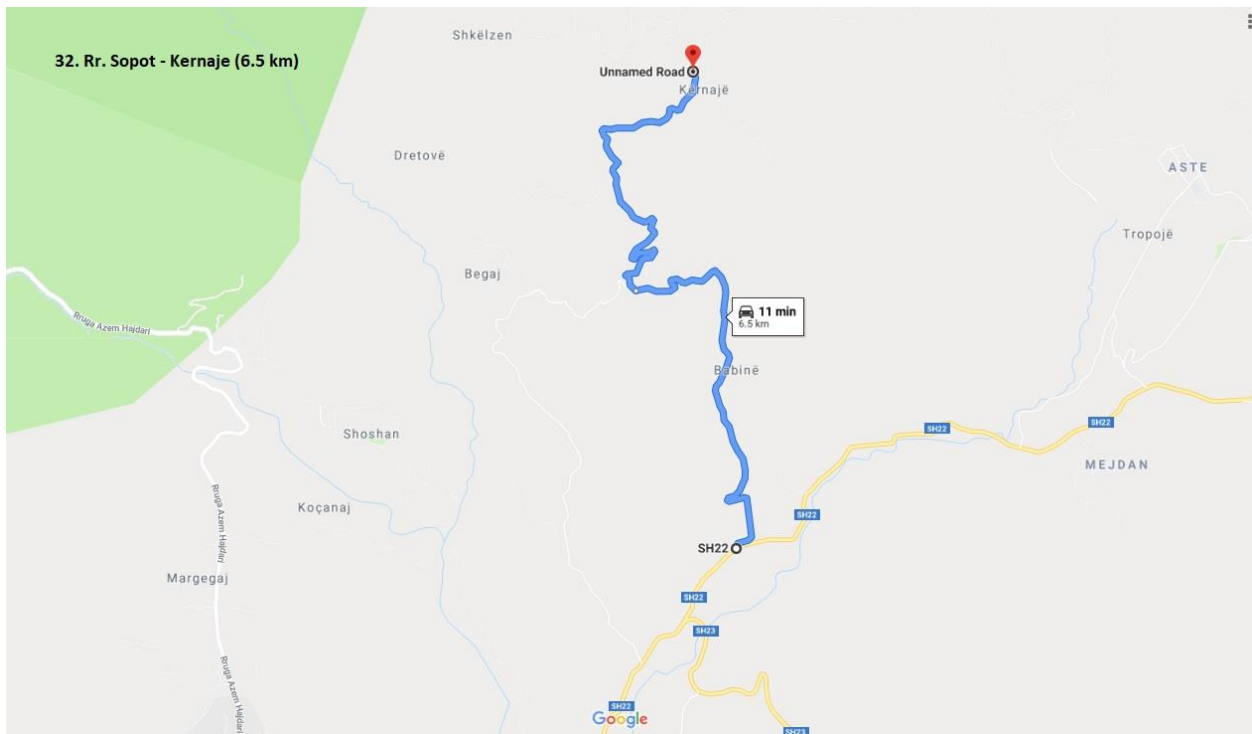
**Sopot-Kernajë 6.5 km**

It is a paved segment with one carriageway (width 4ml).

The asphalt layers' conditions are good.

The side ditches and culverts need partial cleaning.

The road signs and safety need further completion and ongoing maintenance.  
The road lies in a mountainous terrain and is subject to winter maintenance.  
The required level of service is “good”.
