## TECHNICAL REPORT (DESCRIPTIVE REPORT)

Performance-based routine maintenance, "Cereneci Bridge- Klenjë,Trebisht-Customs, Bualli Pass-Kraste, Lapidari Turn-Lis, National Road Intersection-Ulez " 62 km

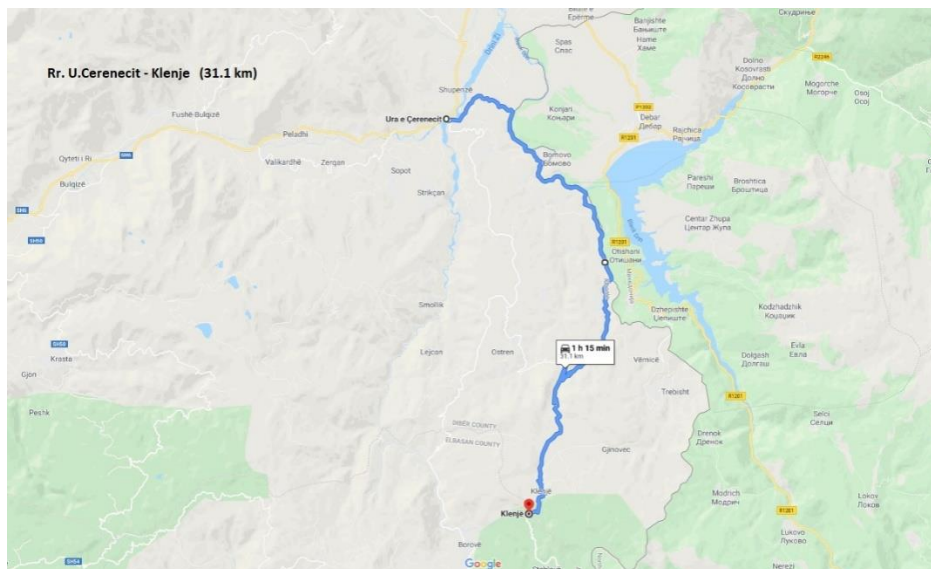
**Cereneci Bridge – Klenjë 31.1 km**

It is an unpaved segment with one carriageway (width 5 ml).

The side ditches and culverts need partial cleaning.

The road signs and safety need further completion and ongoing maintenance.

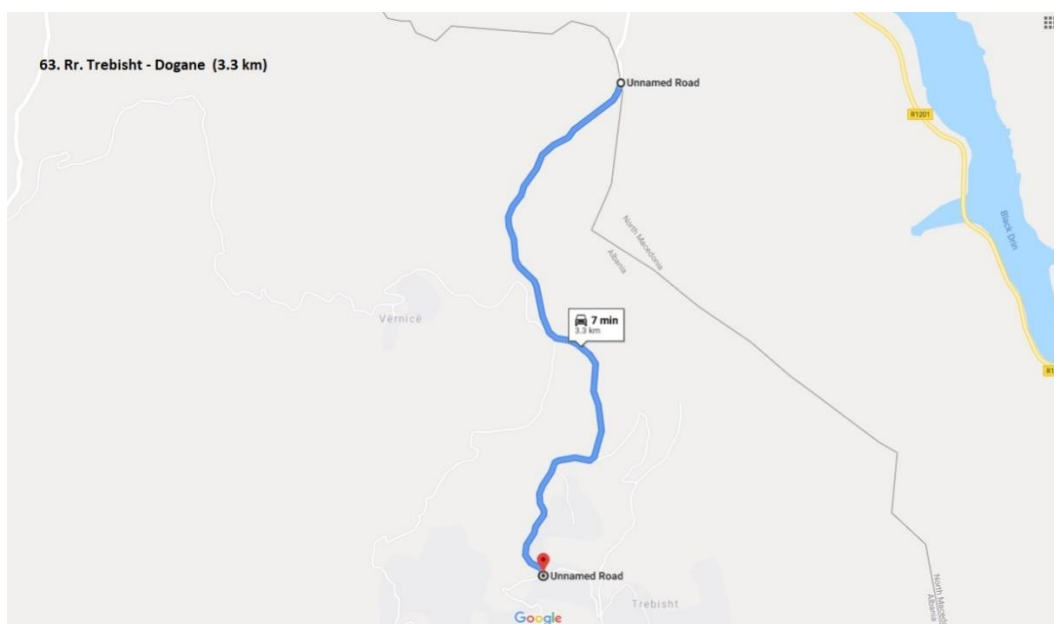
### **Trebisht-Customs 3.3 km**

The asphalt layers' conditions are averagely good.

The side ditches and culverts need partial cleaning.

The road signs and safety need further completion and ongoing maintenance.

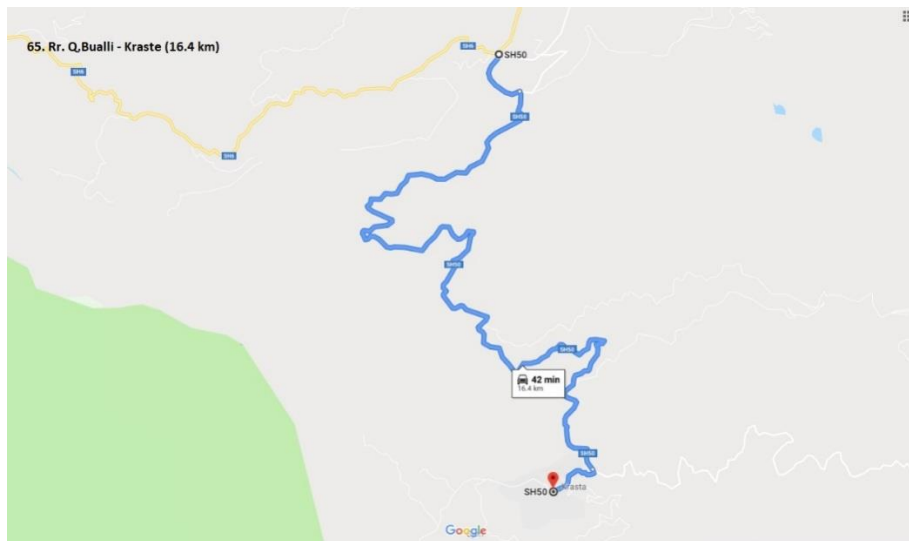
### **Bualli Pass - Kraste 16.4 km**

The asphalt layers' conditions are poor.

The side ditches and culverts need partial cleaning.

The road signs and safety need further completion and ongoing maintenance.

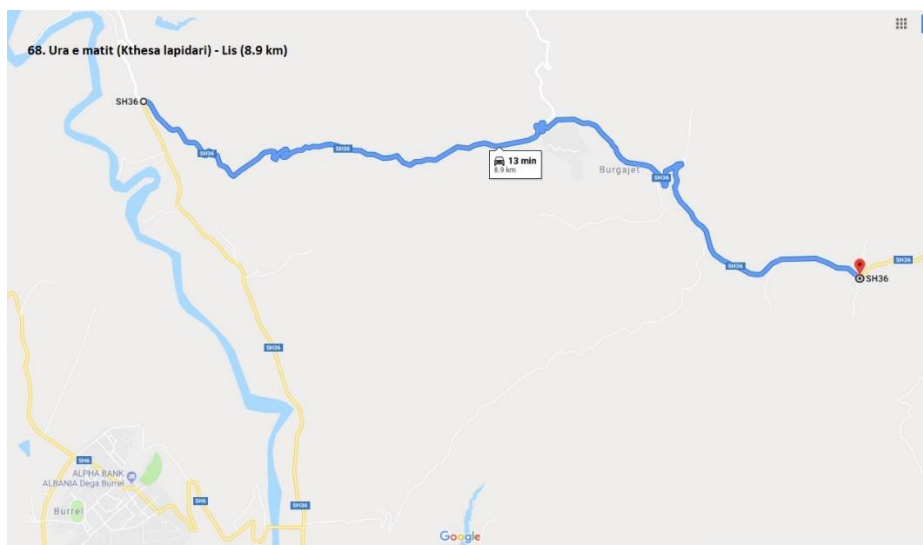
### **Lapidari Turn-Lis 8.9 km**

The asphalt layers' conditions are good.

The side ditches and culverts need partial cleaning.

The road signs and safety need further completion and ongoing maintenance.

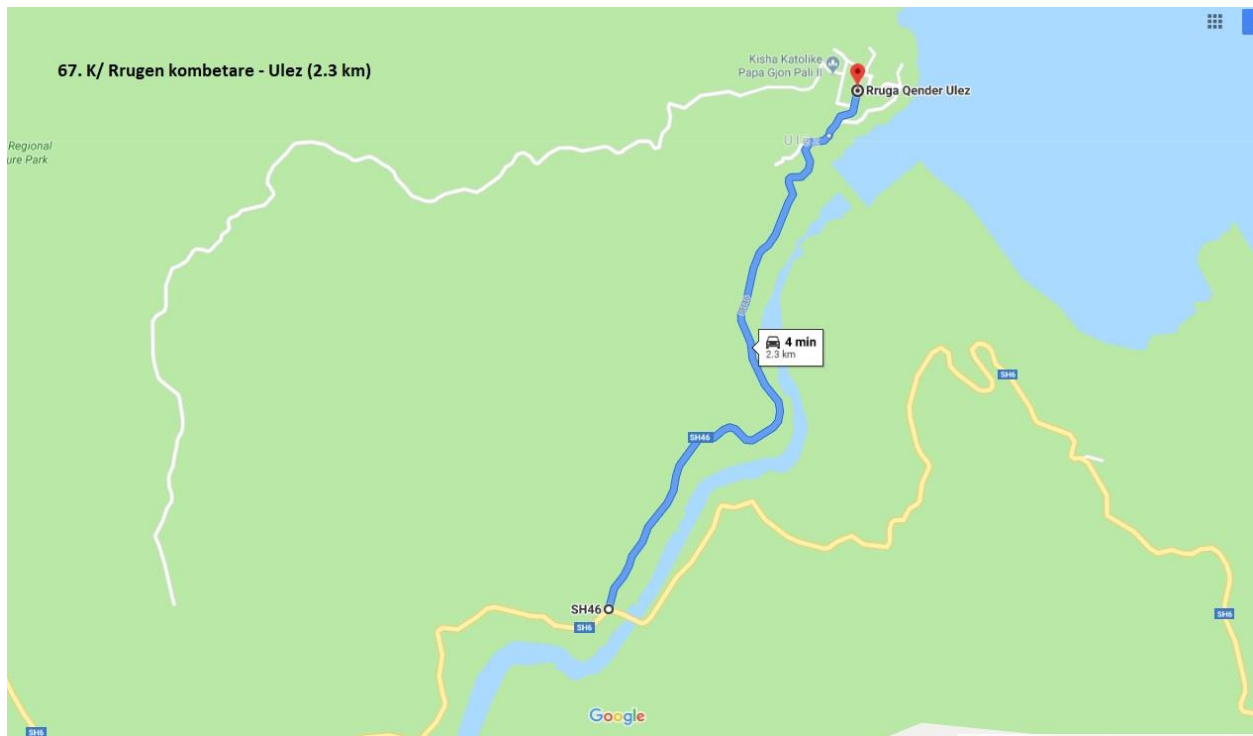
### **National Road Intersection-Ulez 2.3 km**

The asphalt layers' conditions are good.

The side ditches and culverts need partial cleaning.

The road signs and safety need further completion and ongoing maintenance.
