TECHNICAL RELATIONSHIP

RE-ASPALATING OF SEGMENTS ROAD

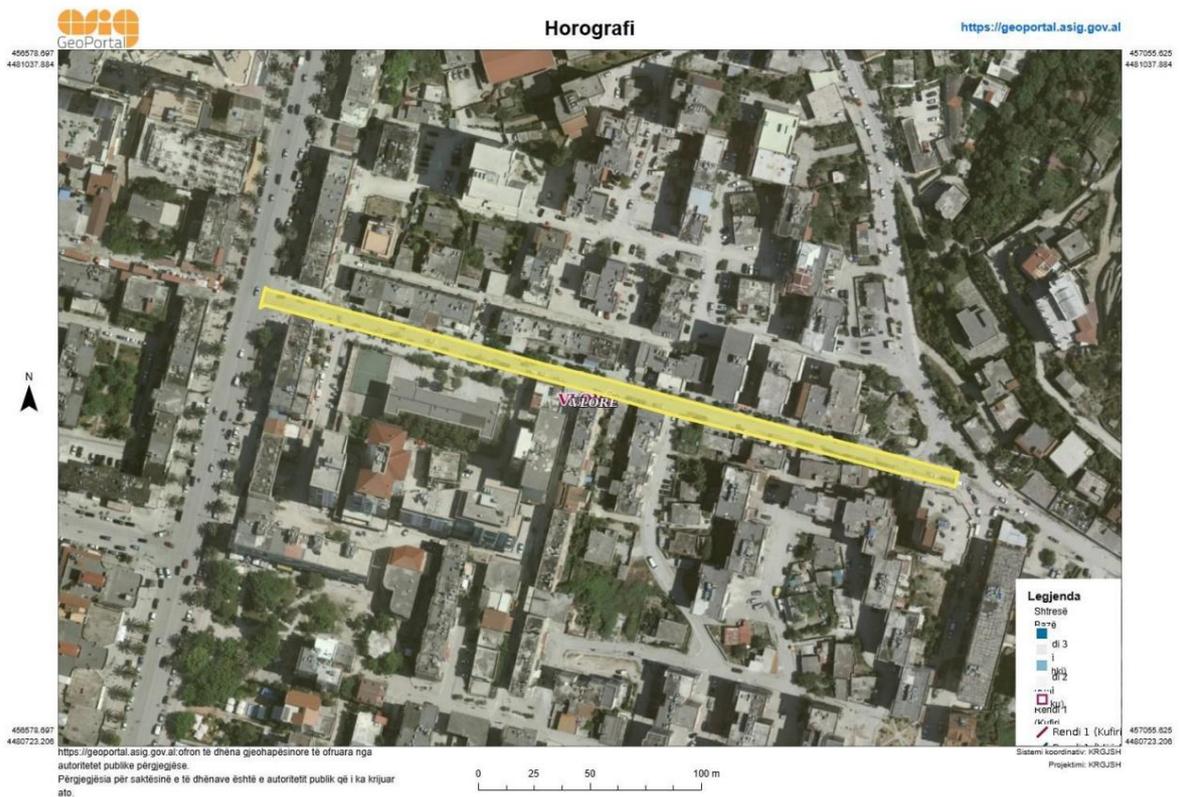
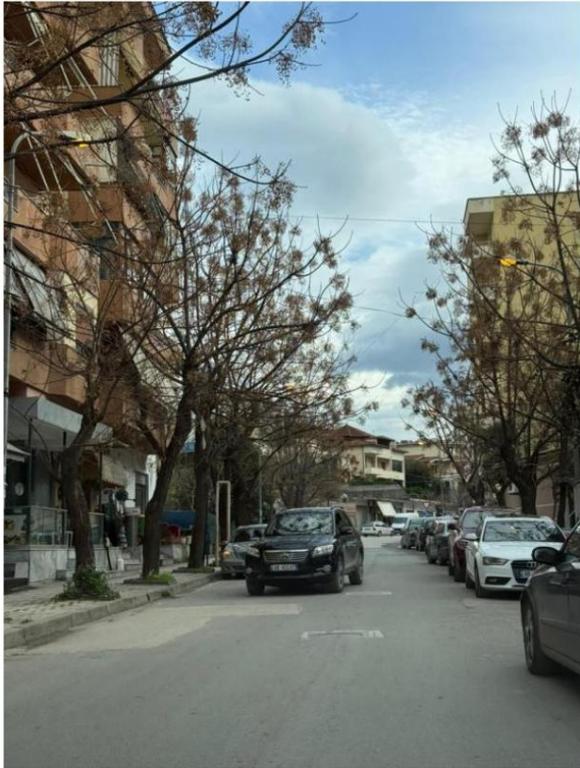
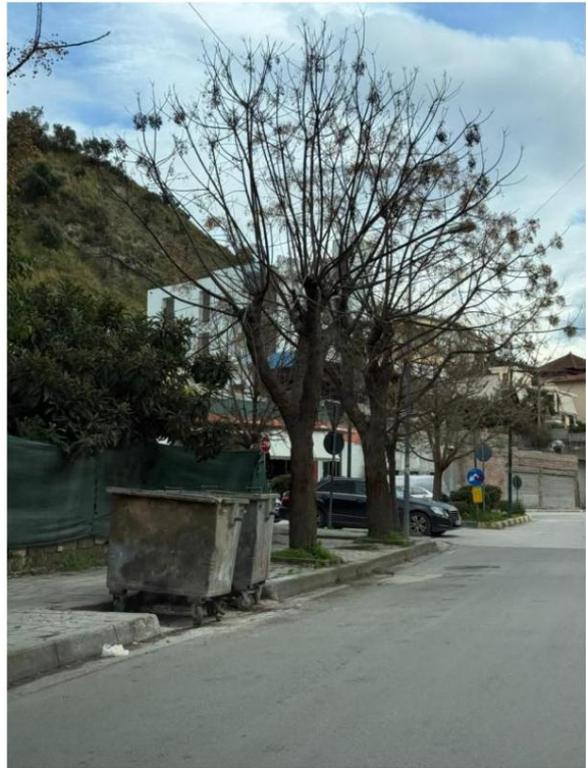
“Mustafa Bello” Street, Region 2

The road is an existing asphalt-paved road, built for years and serving daily vehicle traffic. As a result of the depreciation of the asphalt layer, the impact of atmospheric conditions, interventions carried out for the extension and repair of underground water supply and sewage networks and the lack of periodic maintenance interventions, the road surface presents potholes and local deformations, which make normal vehicle movement difficult and pose a risk to road safety.

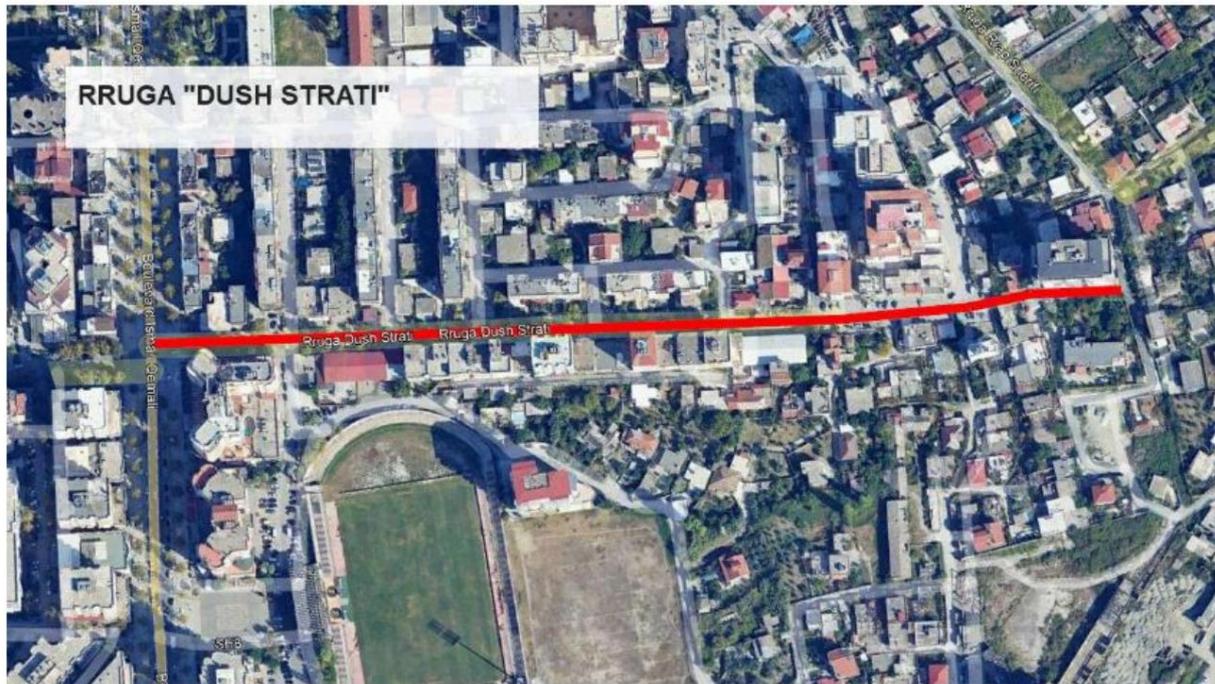
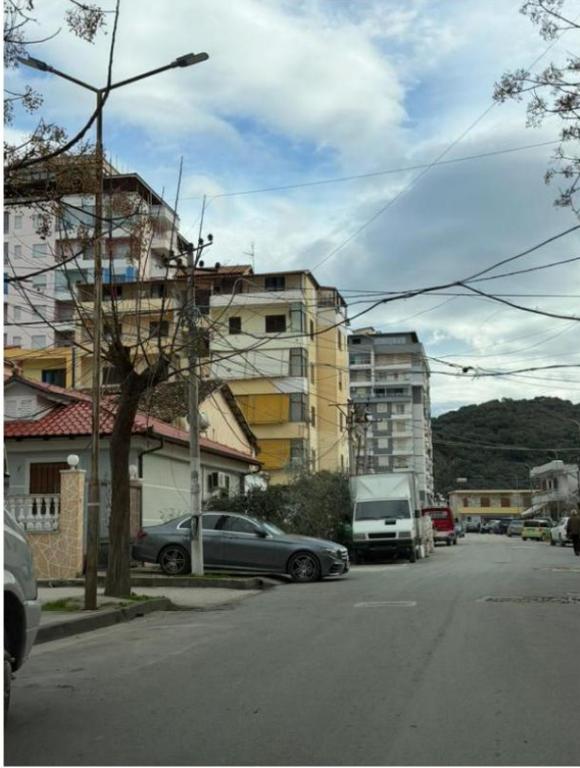
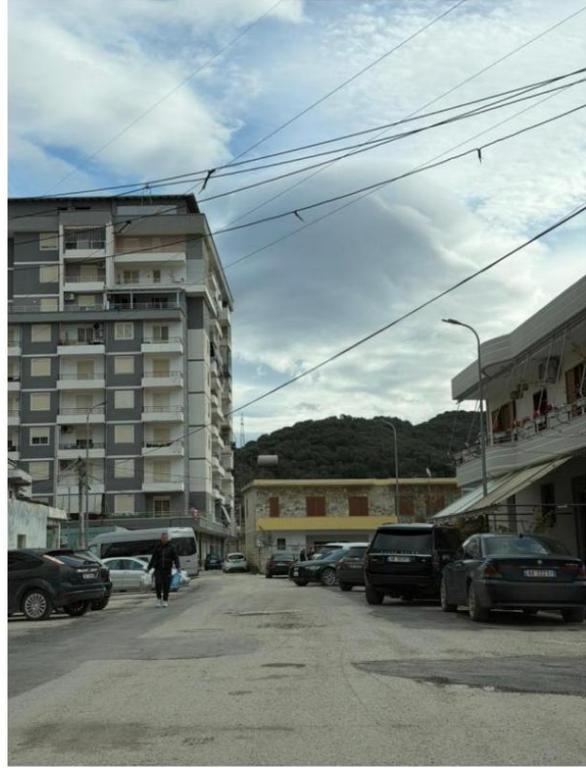
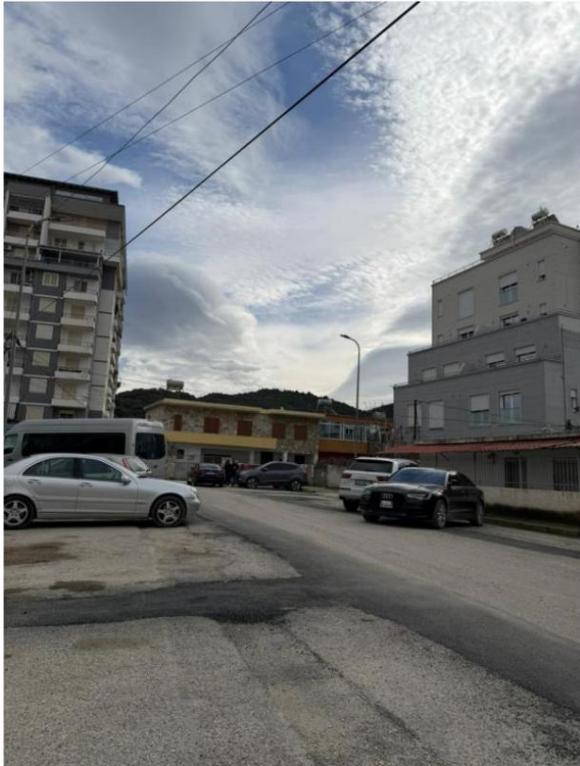
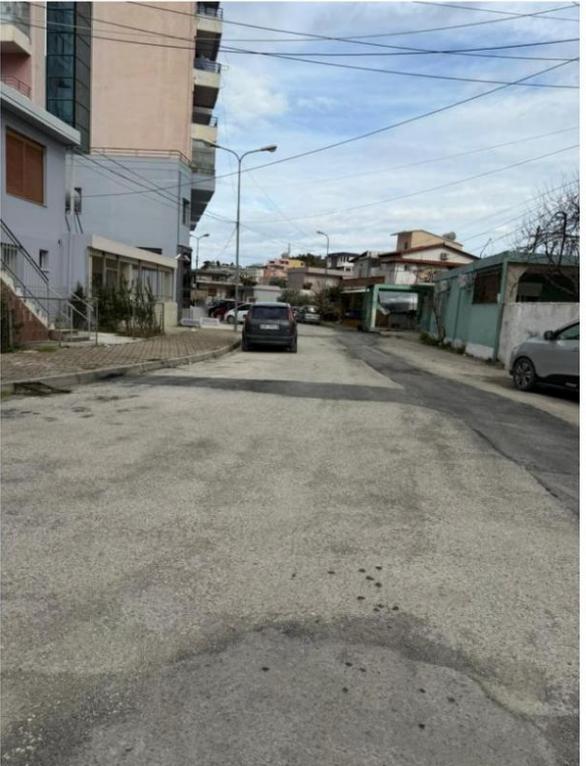
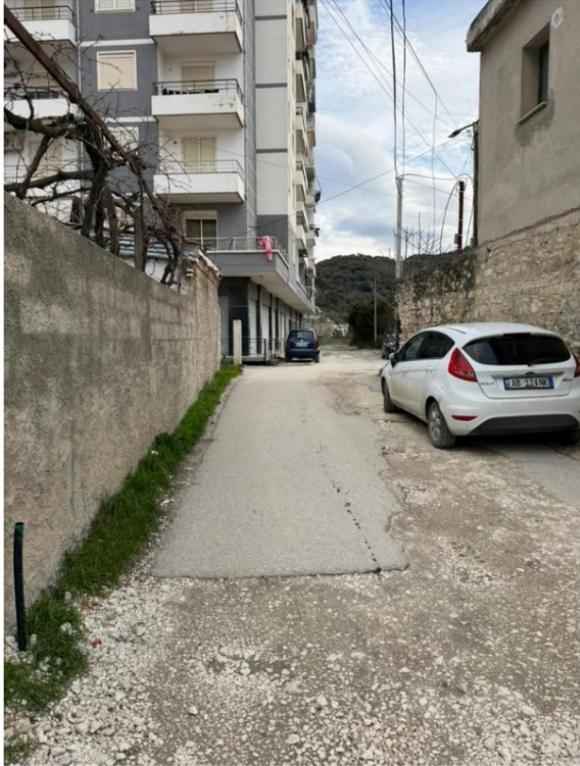
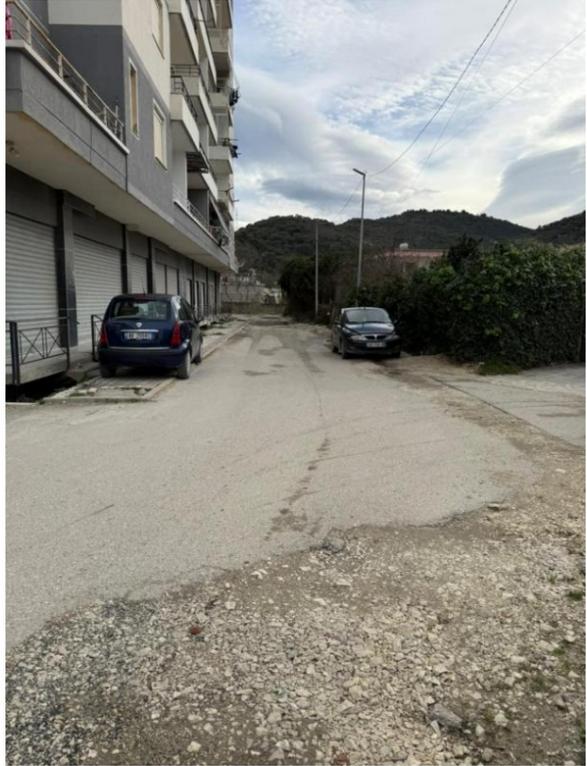
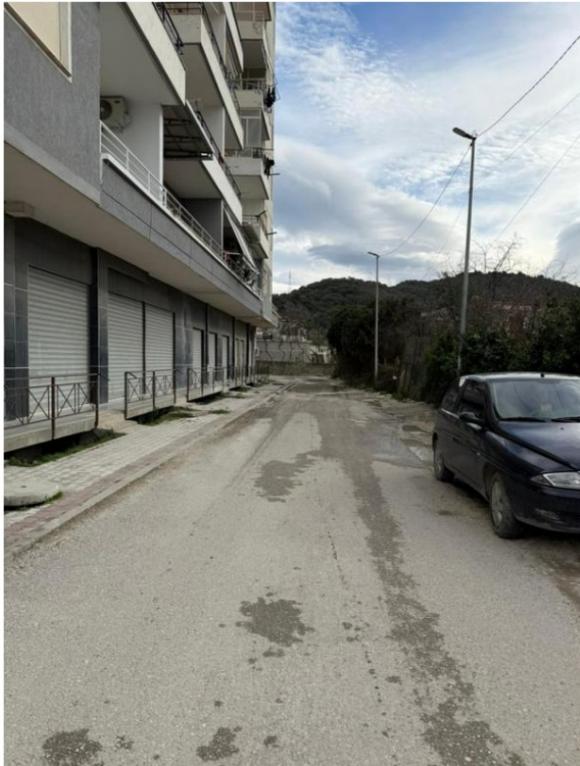
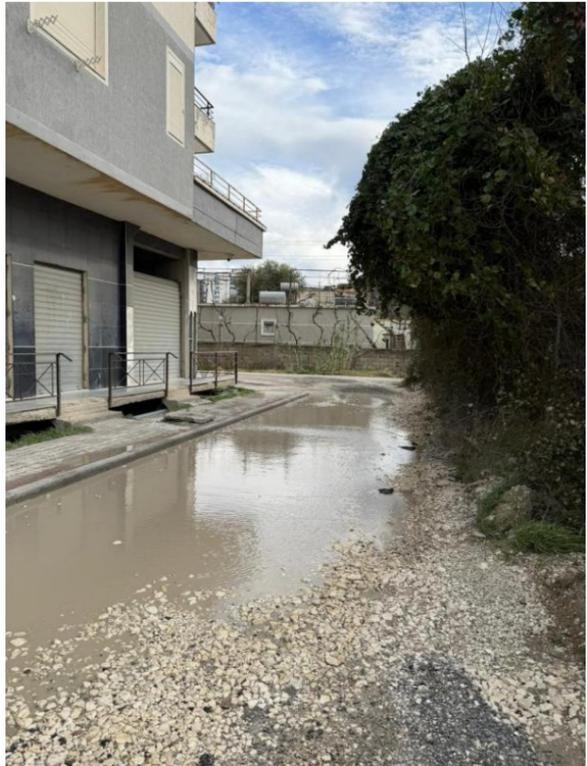
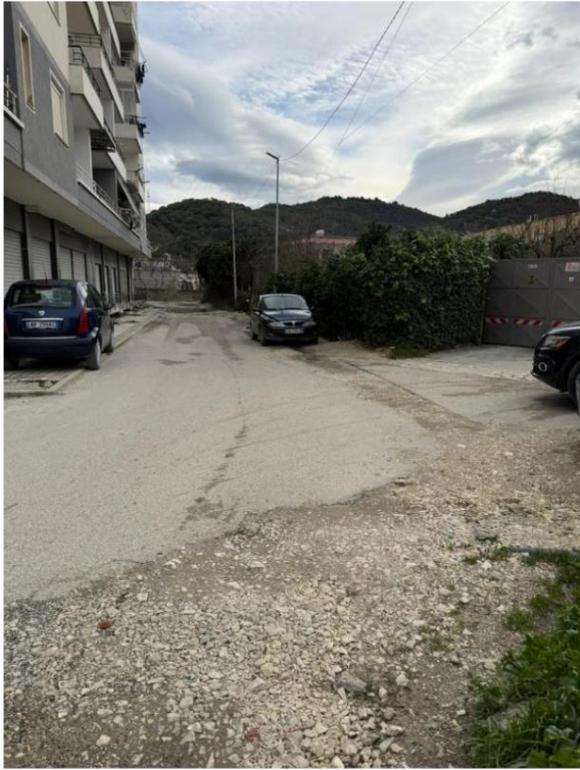
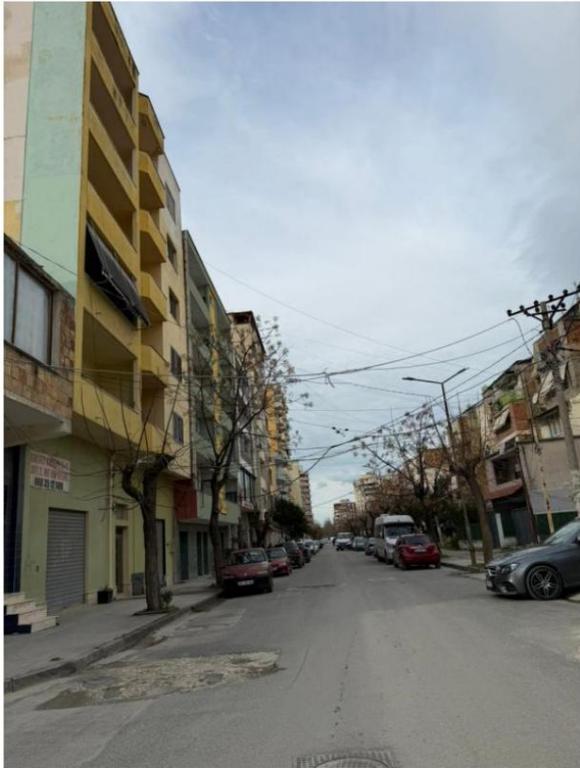
“Dush Strati” Street, Region 2

A two-way local road with worn asphalt, with numerous deformations and repairs on its surface. The road serves as a local axis with a significant flow of vehicles, as well as spontaneously organized parking along both sides of it.

Lack of horizontal signage.

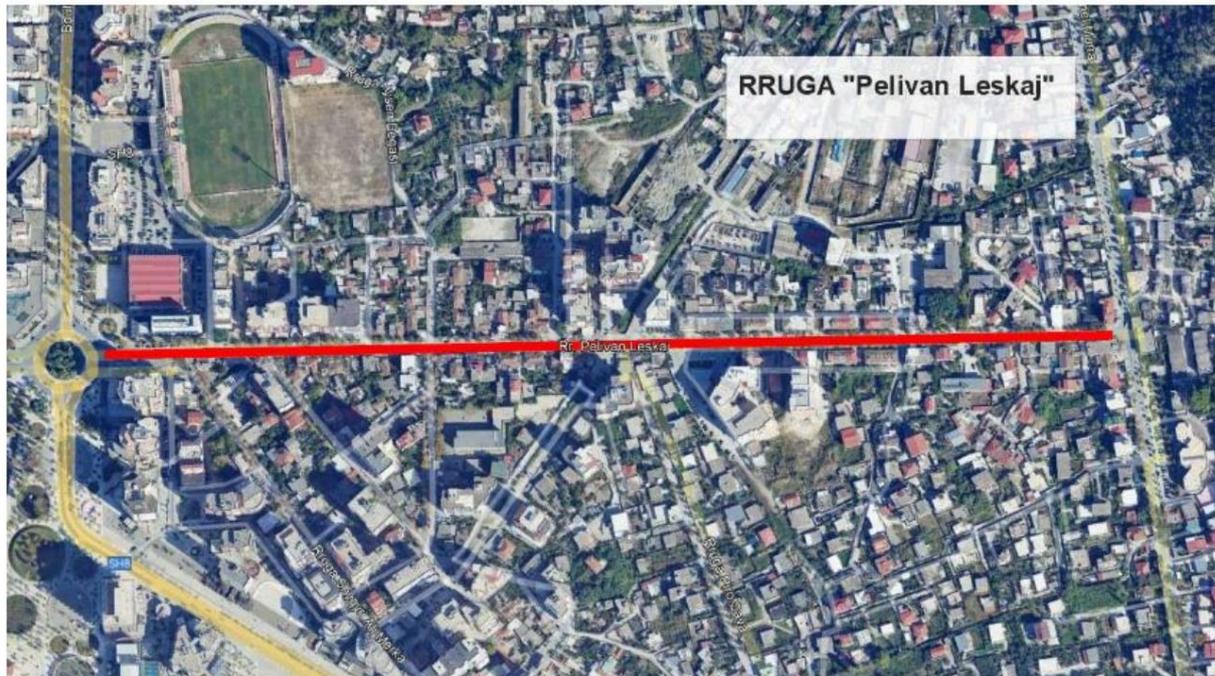
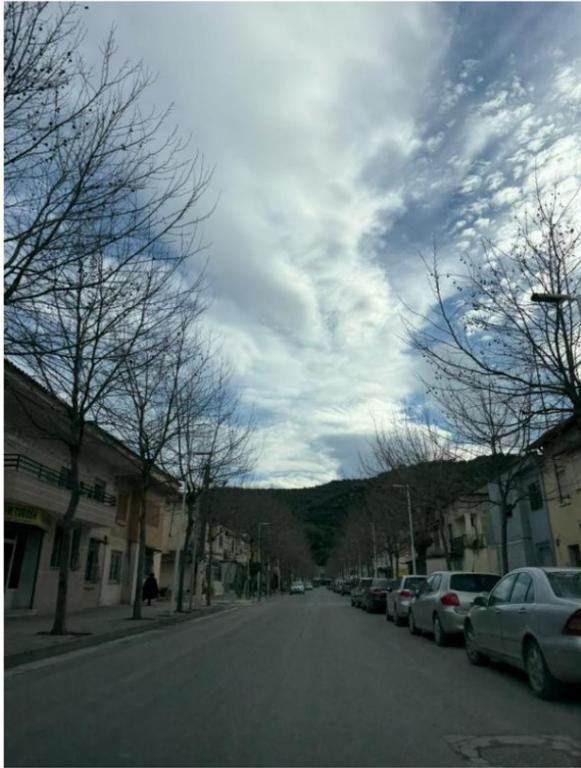
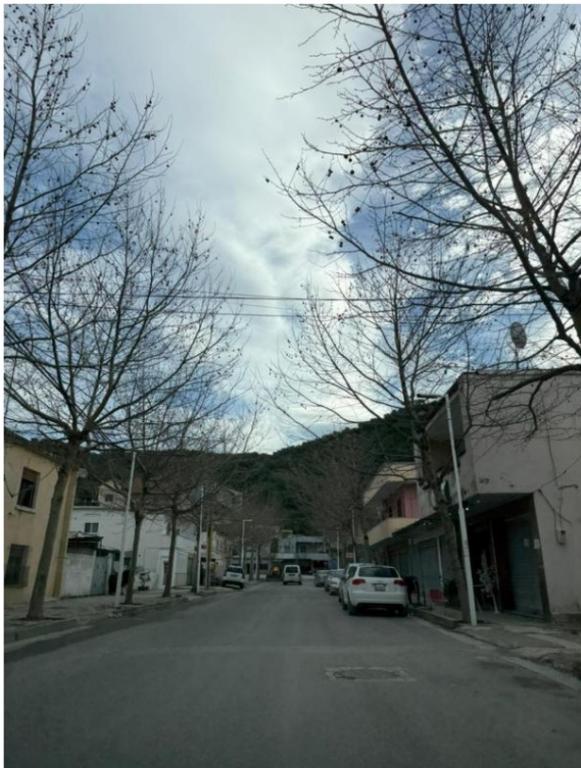
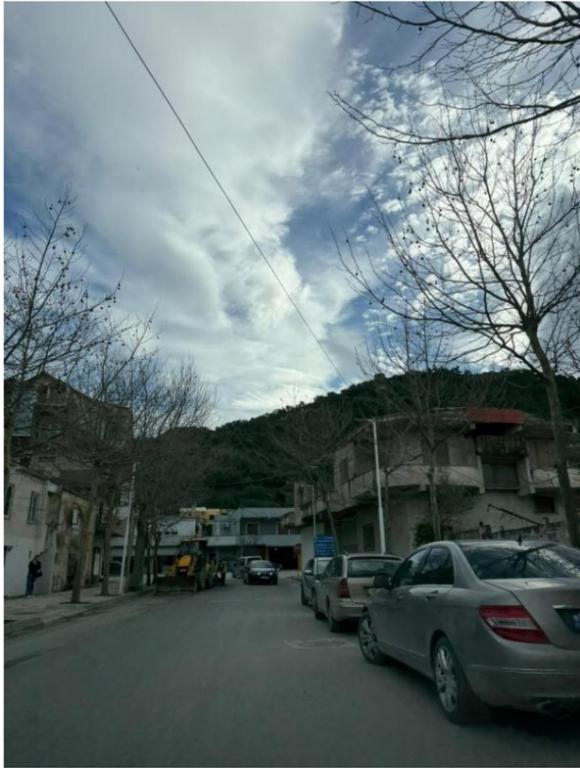
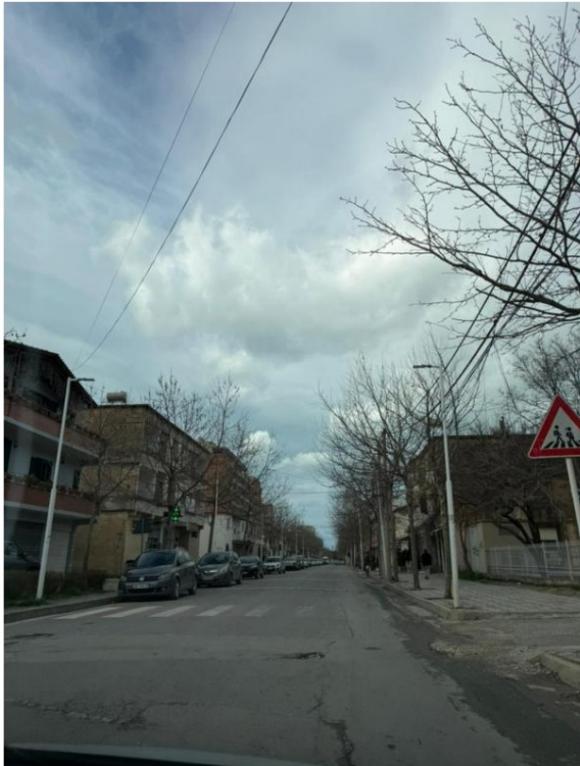
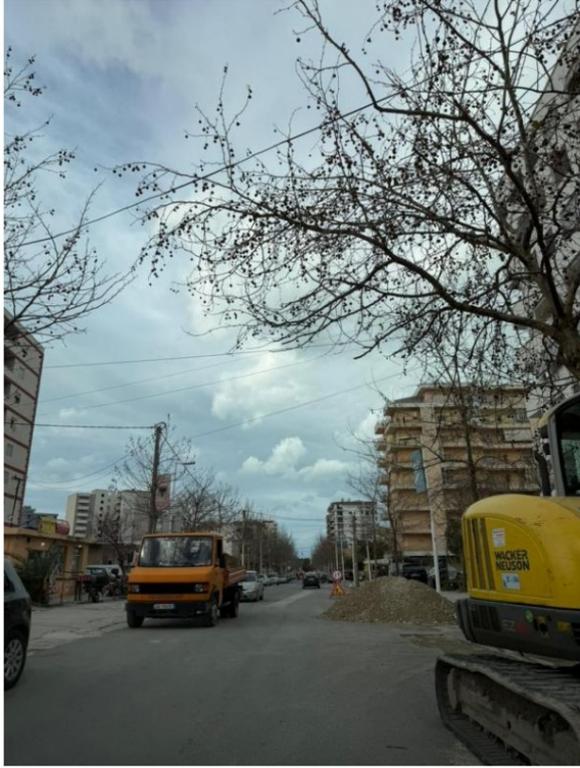
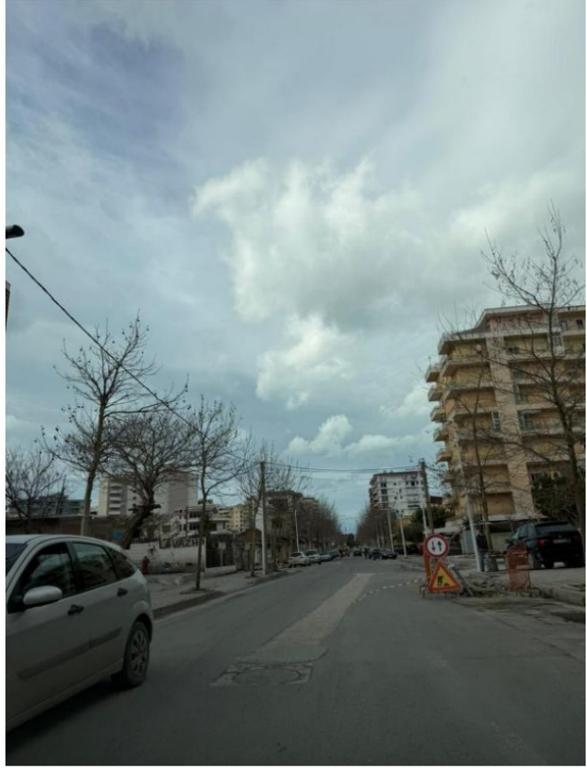
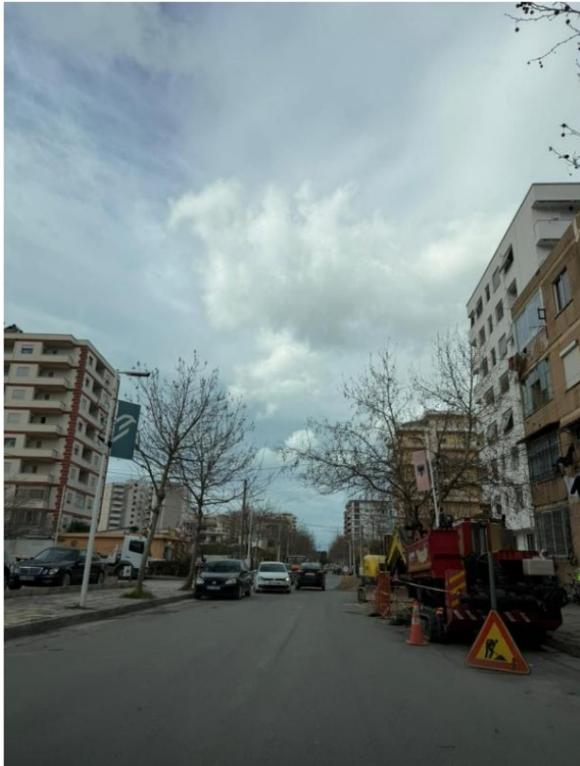
“Pelivan Leskaj” Street, Region 2

A two-way local road with worn asphalt, with numerous deformations and repairs on its surface. The road serves as a local axis with a significant flow of vehicles, as well as spontaneously organized parking along both sides of it.

Lack of horizontal signage.

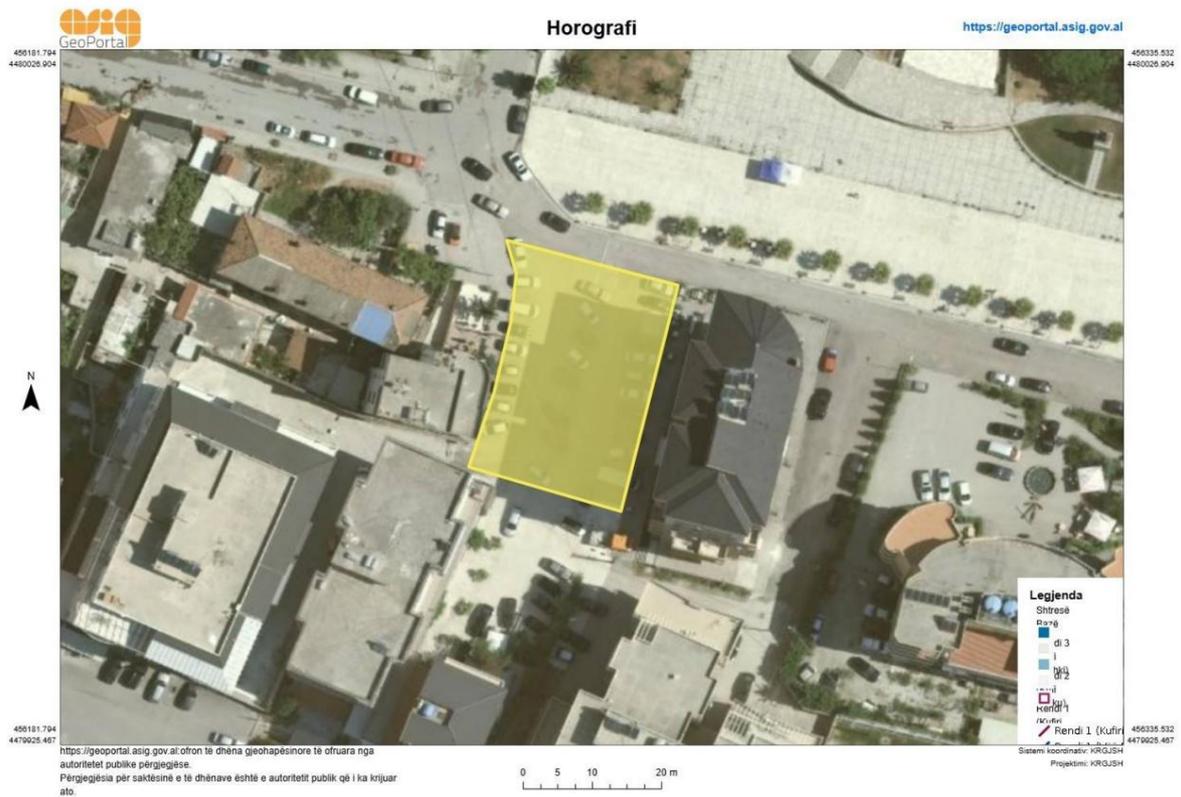
Parking at "San Giorgio", Region 2

The parking lot is unpaved and presents significant damage to the surface layer. Numerous potholes, surface deformations, gravel, and water puddles are observed due to the lack of regular drainage. This condition makes vehicle movement difficult and creates unsuitable conditions for circulation, especially during rainfall.
